MEMO

Department of Public Works

DATE: November 6, 2015

SUBJECT: Emergency Storm Drain Repairs of Various Corrugated Metal Pipe (CMP)
CIP No. DR202 and DR204

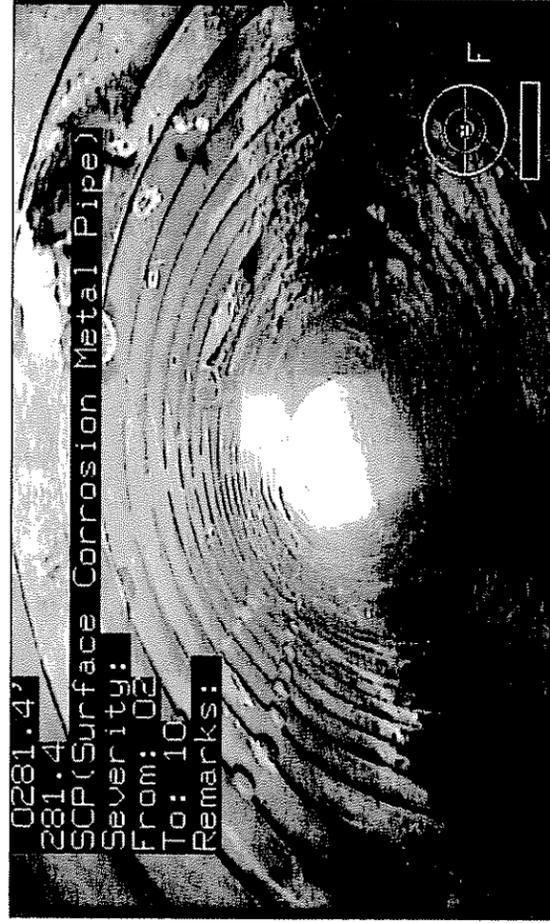
Loss of Structural Integrity

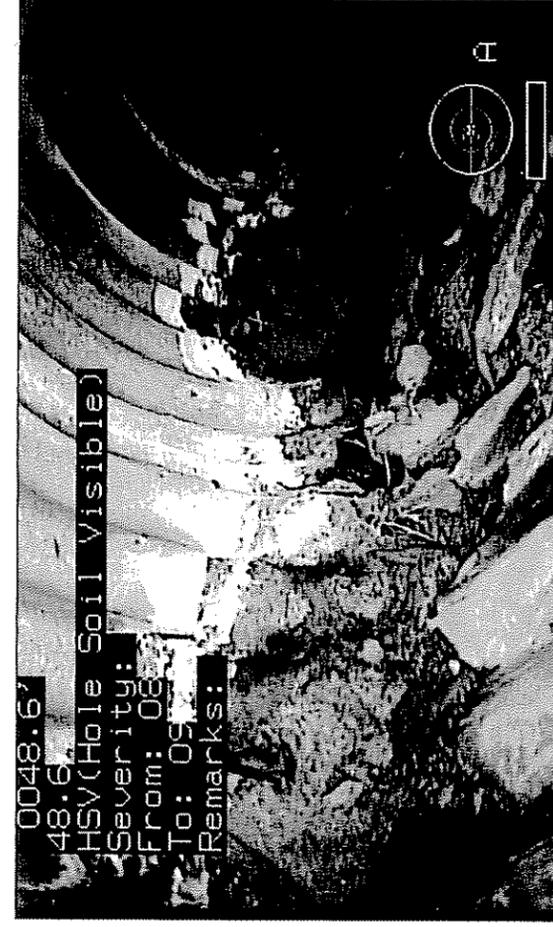
Loss of backfill and large void surrounding pipe

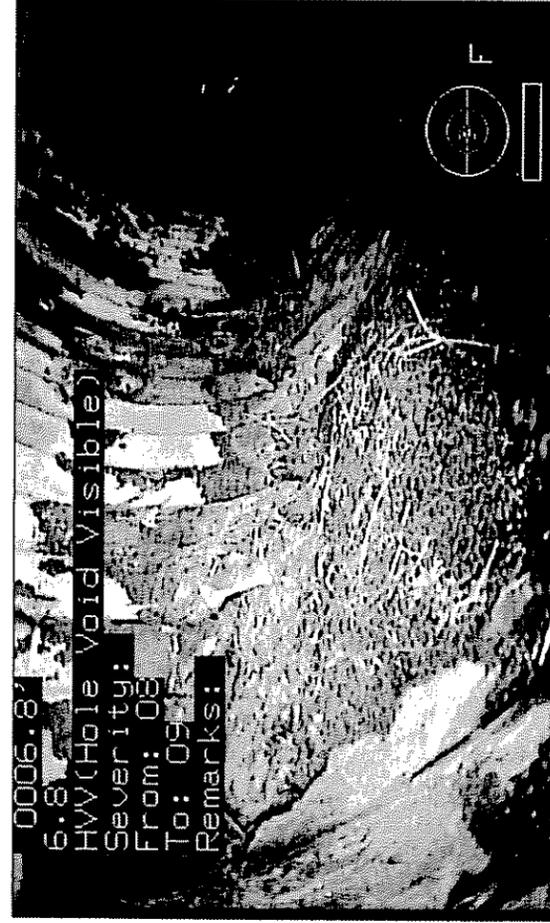
Loss of backfill and large void surrounding pipe

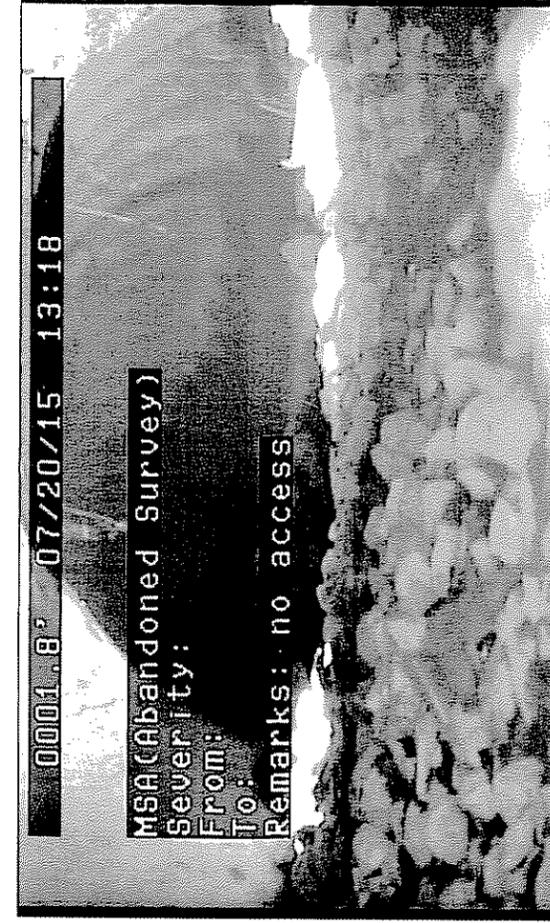
Loss of pipe bottom

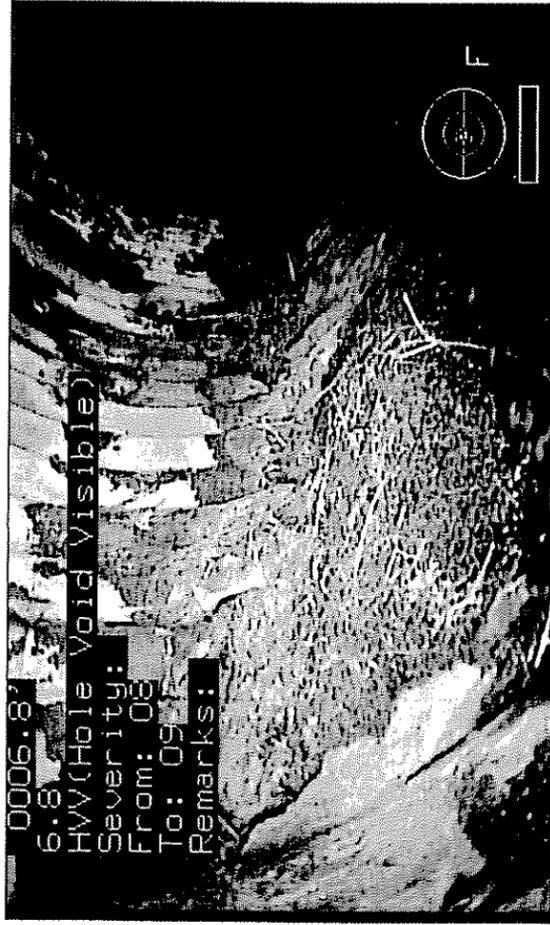
Loss of backfill and large void surrounding pipe

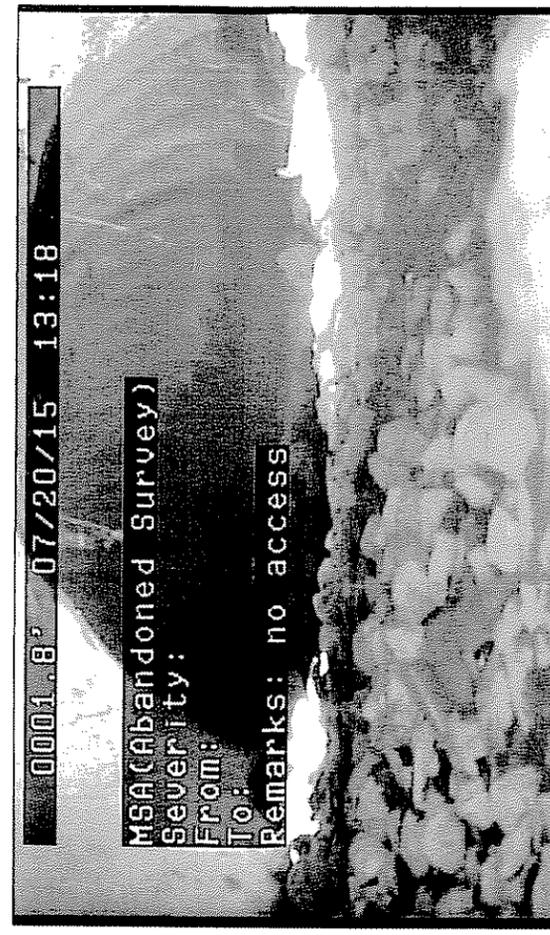
Loss of pipe bottom

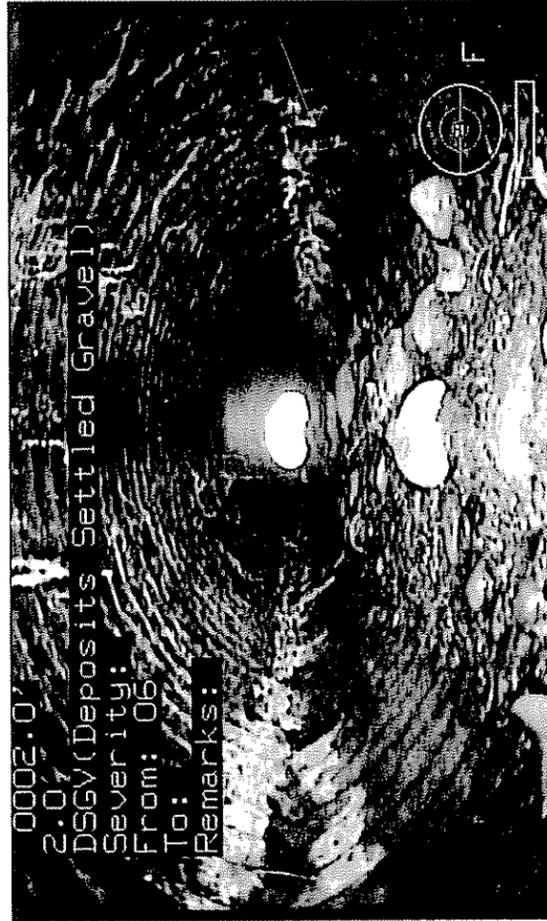
Loss of Structural Integrity

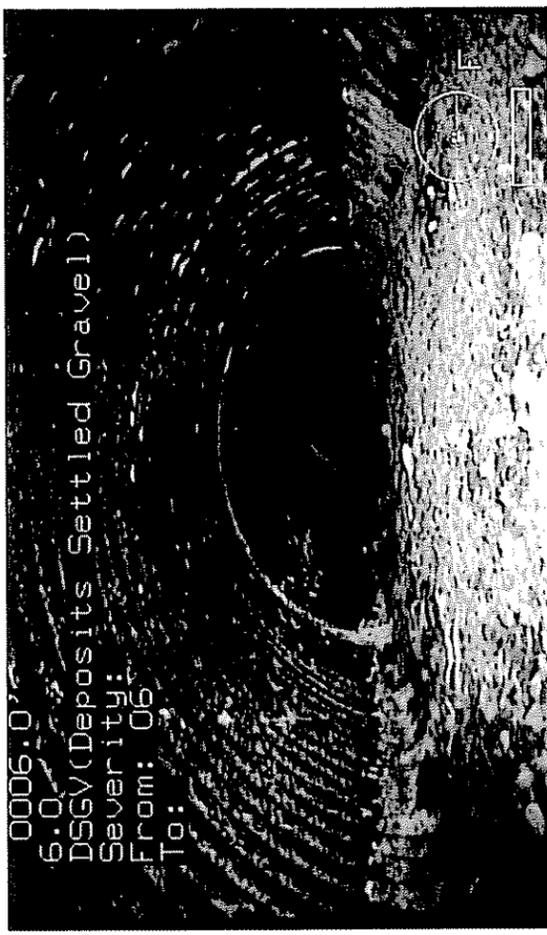
Loss of Structural Integrity

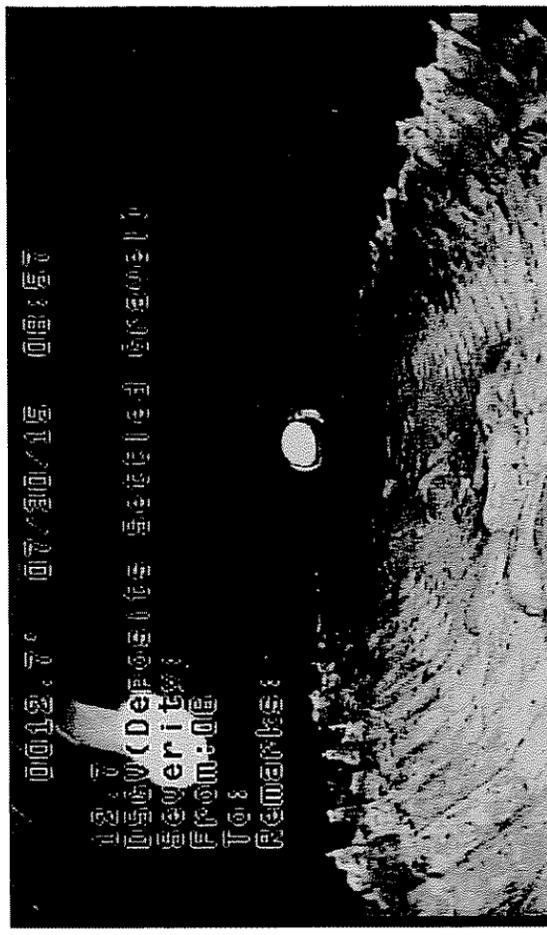
Loss of pipe bottom

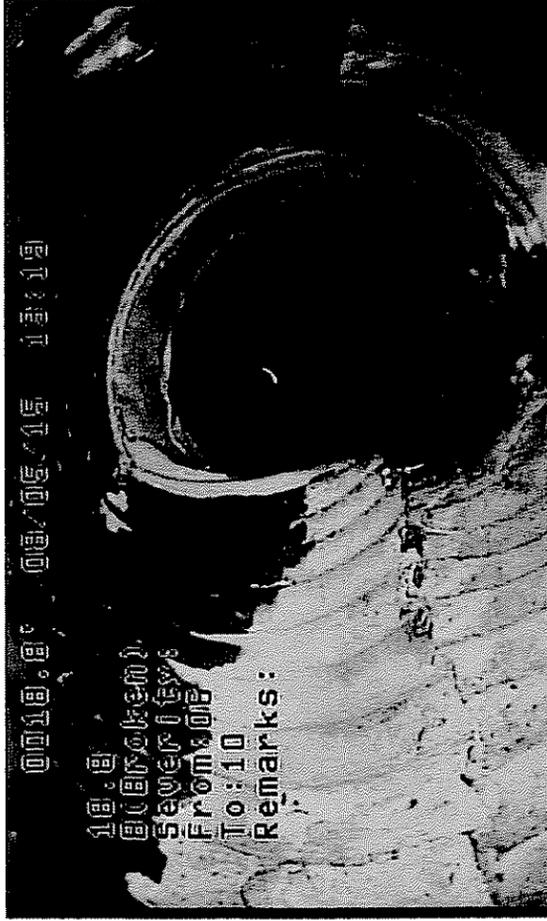
Loss of Structural Integrity

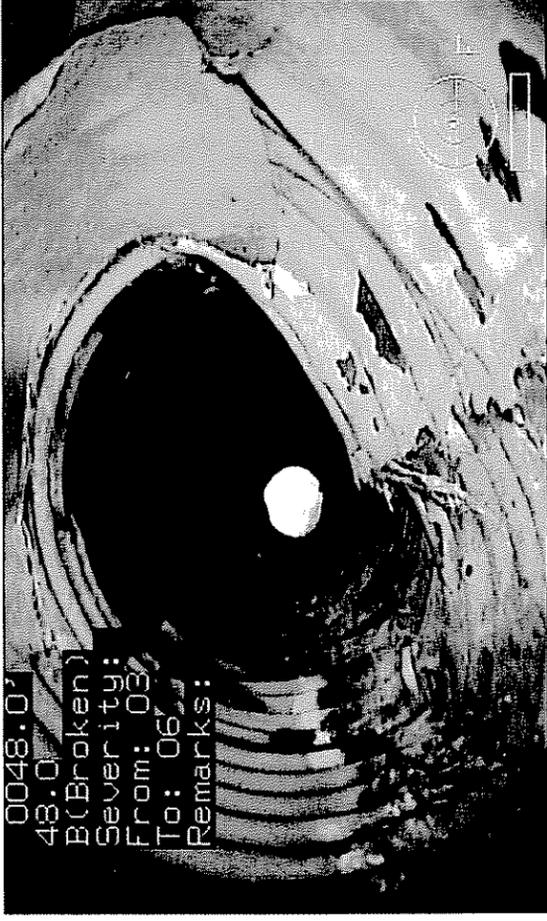
Loss of Structural Integrity

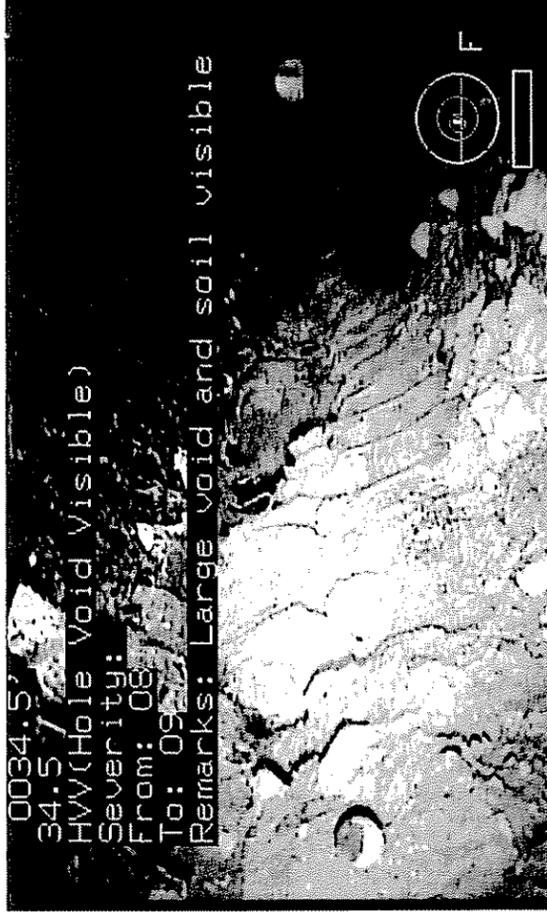
Loss of backfill and large void surrounding pipe

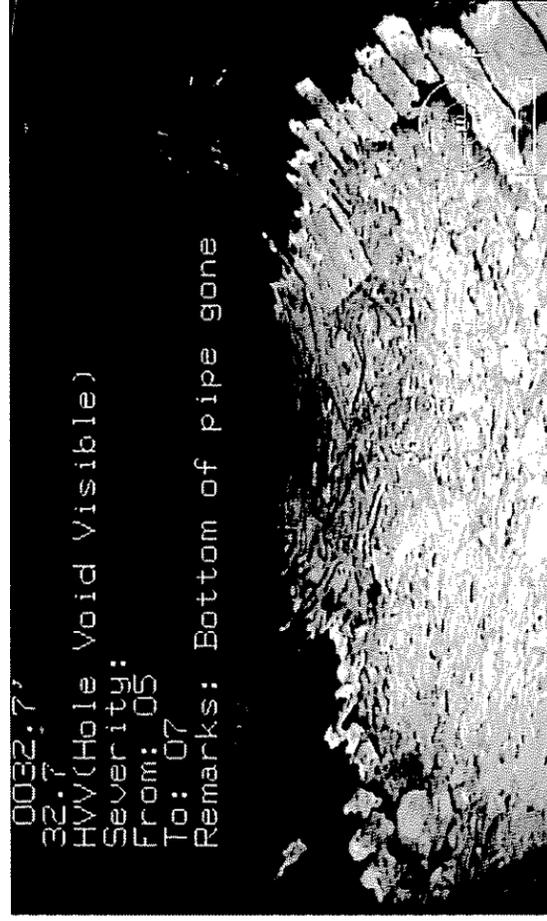
Loss of pipe bottom

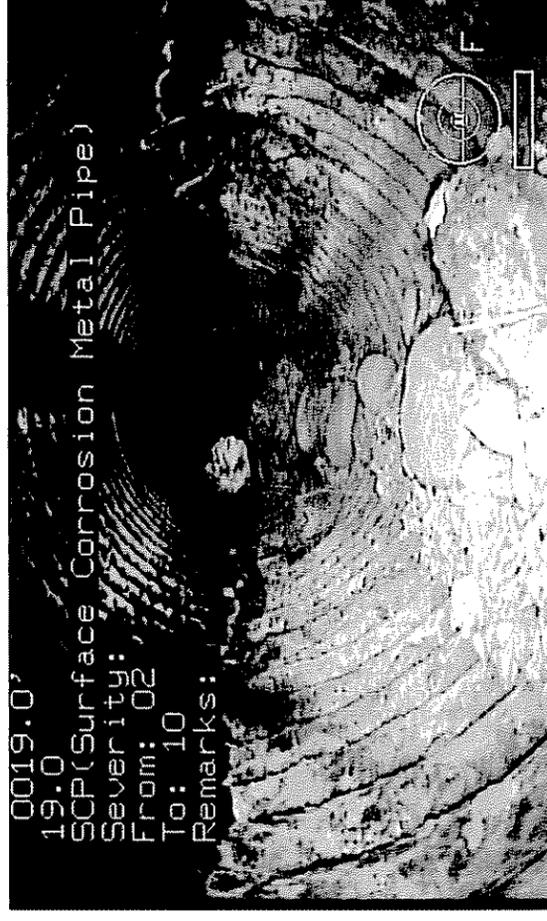
Loss of Structural Integrity

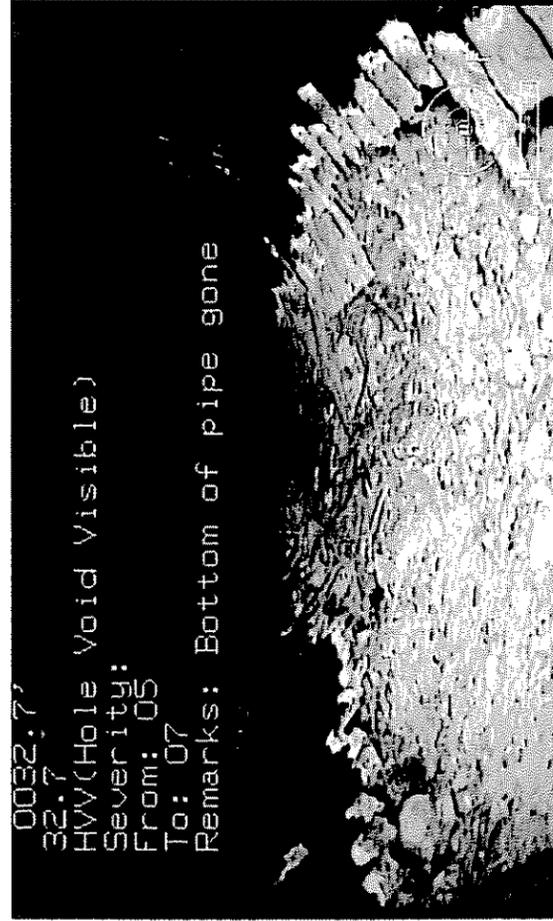
Loss of pipe bottom

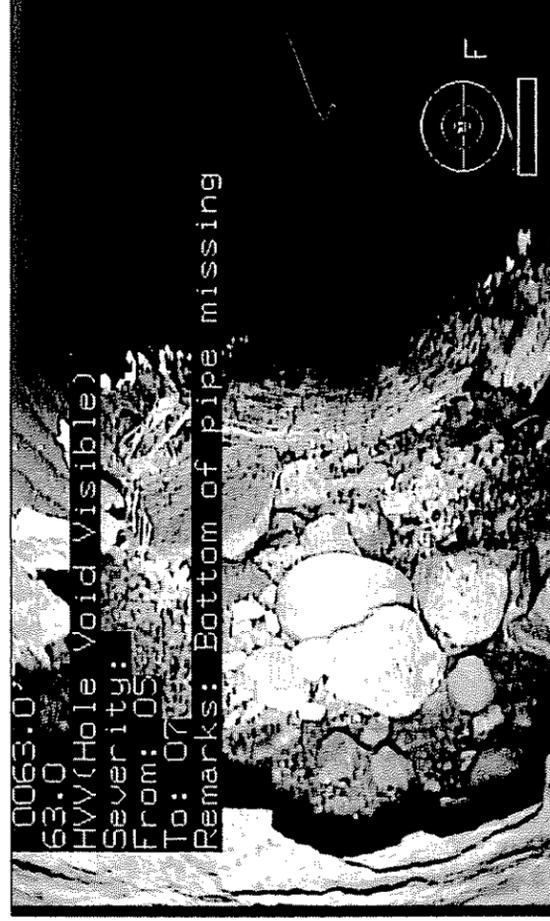
Loss of pipe bottom

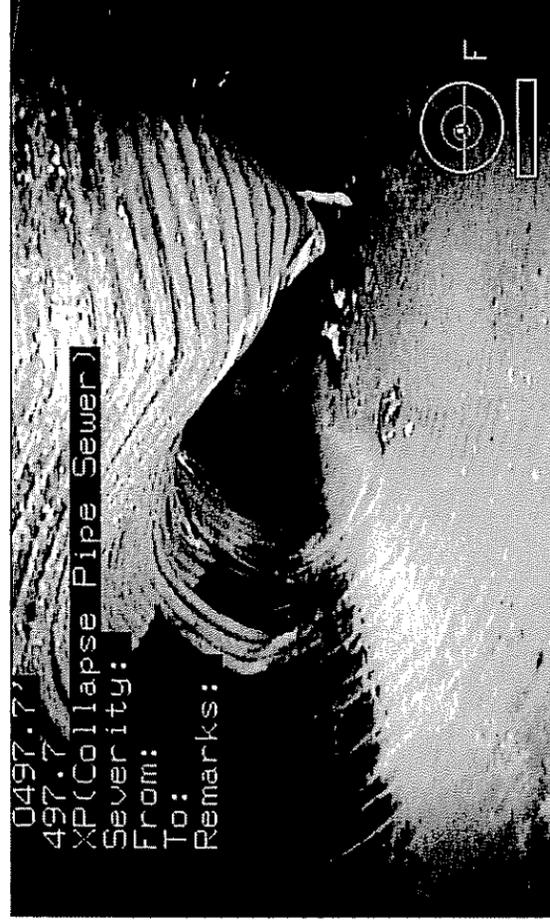
Loss of Structural Integrity

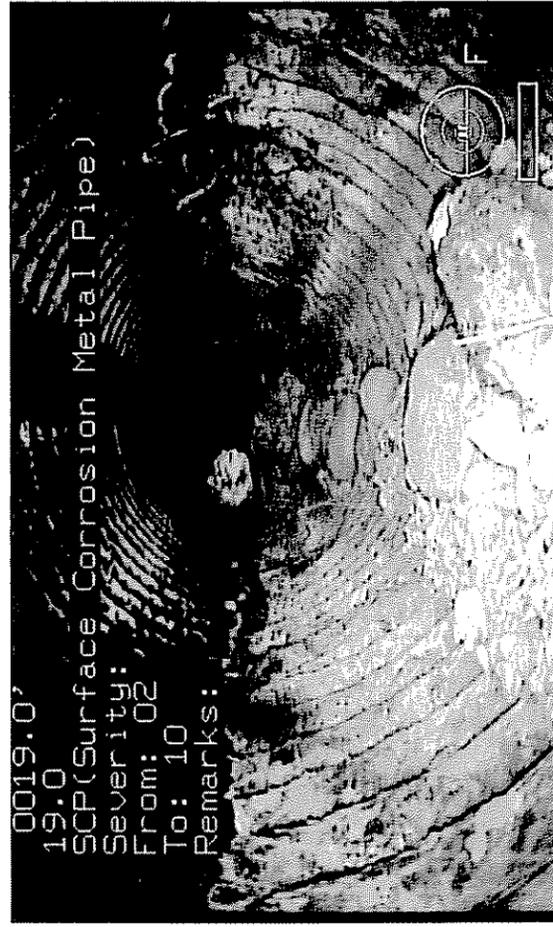
Loss of Structural Integrity

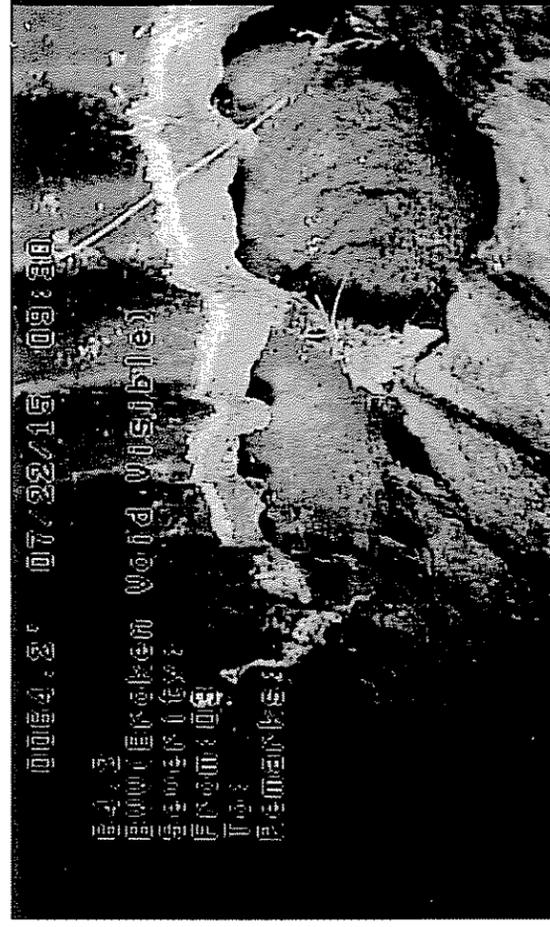
Loss of backfill and large void
surrounding pipe

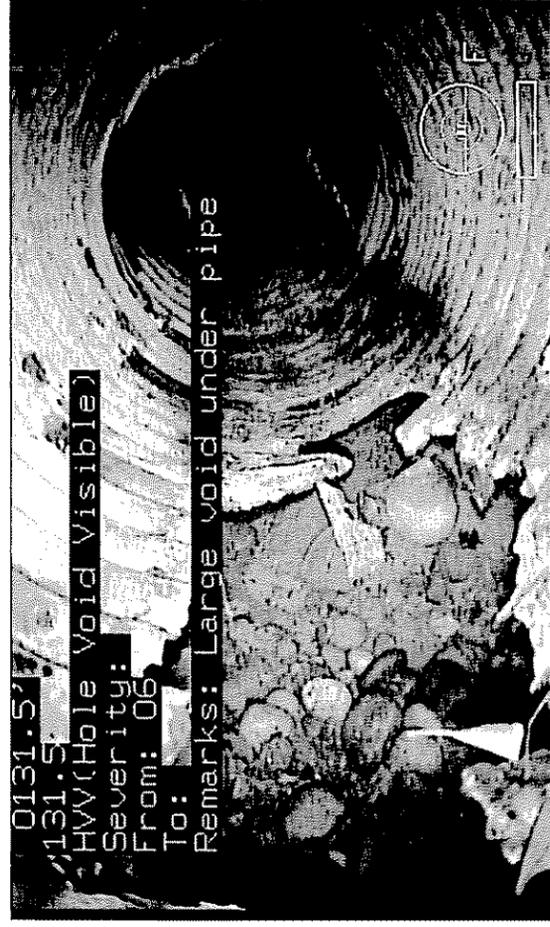
Loss of pipe bottom

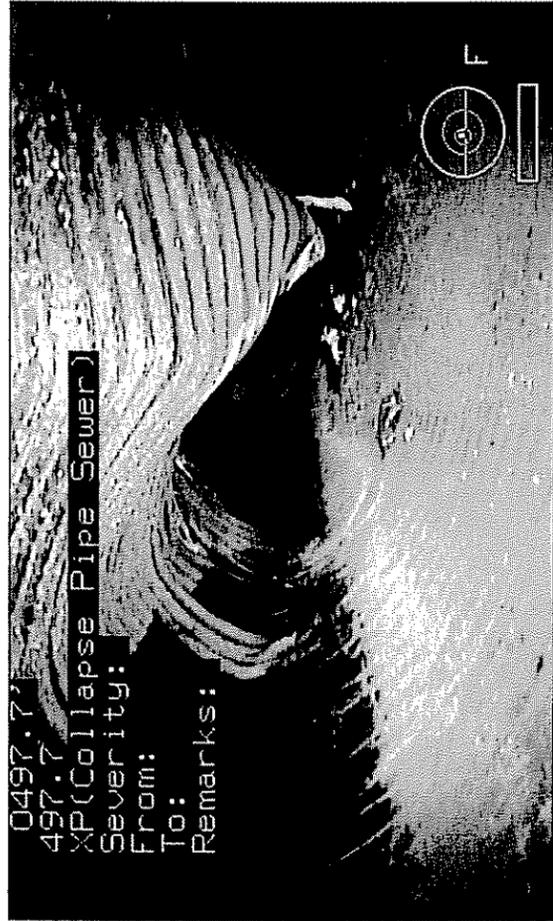
Loss of Structural Integrity

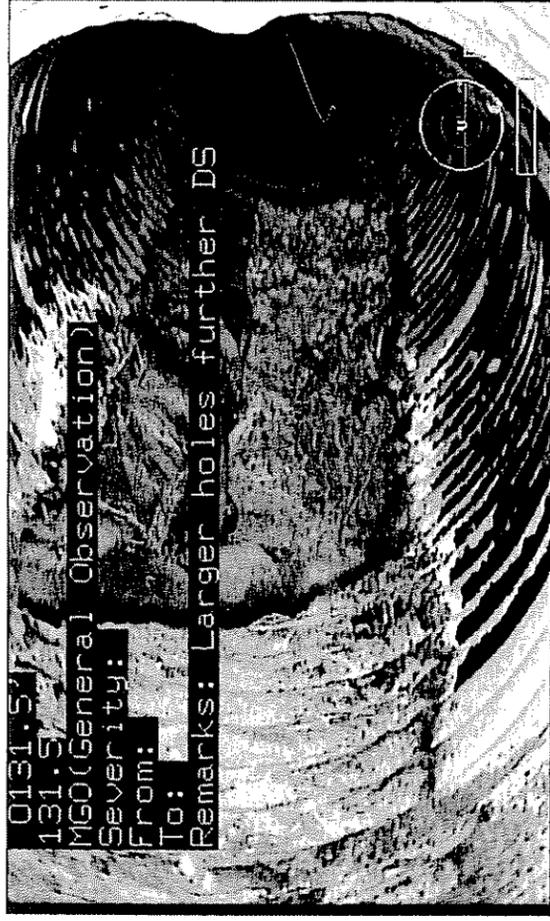
Loss of backfill and large void surrounding pipe

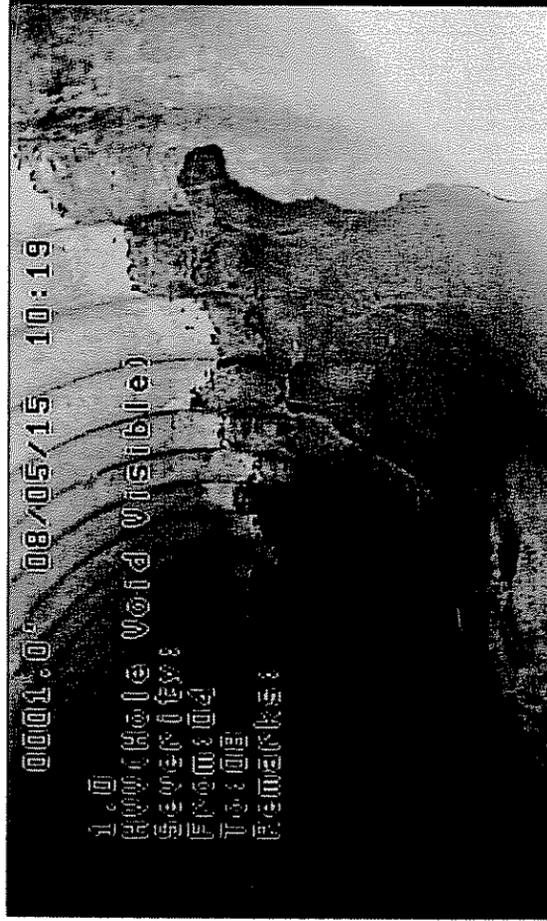
Loss of backfill and large void surrounding pipe

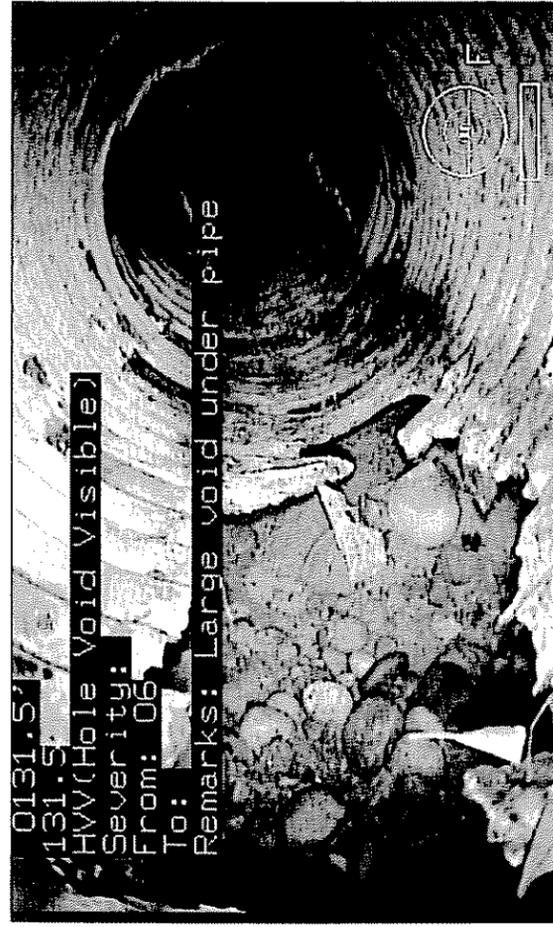
Loss of pipe bottom
