Re.: 50 F Street – Building Official and Fire Marshal Evaluation

The owner of the property has requested that the City consider delisting the building at 50 F Street from the City's Historic Resources Register. At the request of Planning Division staff, on January 10, 2017, the City's Building Official (BO) and Fire Marshal (FM) visited the property to evaluate the current condition of the building and determine if it constitutes a hazard or pose any threat to public safety. Staff performed a visual inspection of the outside and inside of the building and took pictures. This letter serves as the BO's and FM's evaluation of the current condition of the building.

Attachment - 50 F Street – Pictures Taken on January 10, 2017

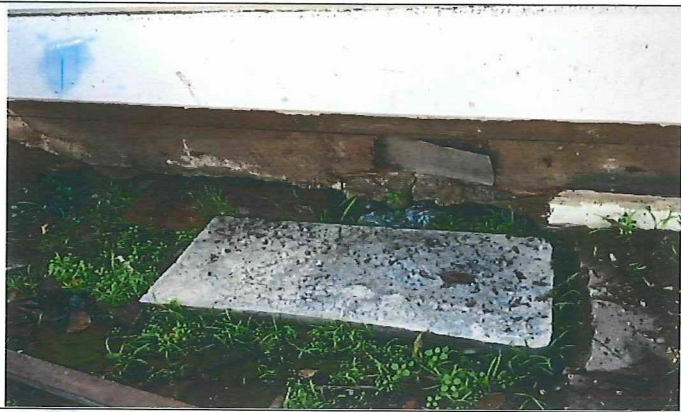
Picture 1

Portions of the building foundation along the southern exterior wall seem to have been undermined and crumbled, and a minor settlement observed along the southern wall of the two story portion. Furthermore, some of the walls and ceilings have lost the interior finishing plaster and wood sheathing. Overall deterioration and inadequacy of its foundation and walls have increased the vulnerability of the building to strong winds and earthquakes. In its current condition, the building is unsafe for occupancy. (Photos 1, 2, 3, 7, 8, 9, 10 and 11)

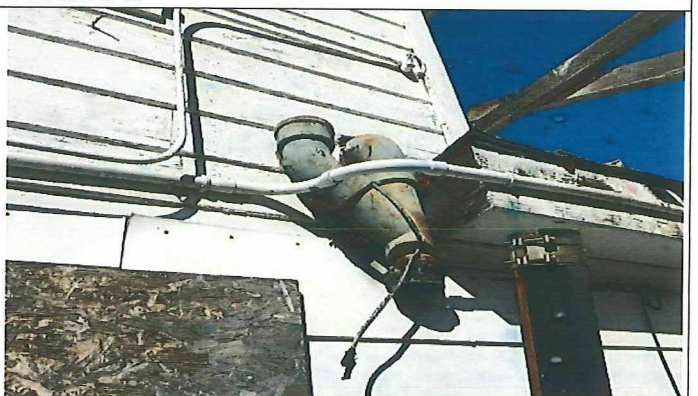
Picture 4

The building is currently being used as storage of personal items. Based on its current condition, the building is unsafe for occupancy. (Pictures 1 through 16)

Based on the current condition; inadequate maintenance, dilapidation, decay, damage, inadequate light, air and sanitation facilities, the building is unfit and unsafe for human habitation. (Pictures 1 through 16)

The building has an old and potentially dangerous electrical wiring system (porcelain knob and wire) which staff was told is not in use. A separate and more recent electrical panel and wiring to some areas of the building were installed and the City has no record of permitting or inspecting the newer system. Un-permitted/un-inspected electrical could potentially be faulty electrical creating a potential fire or electrical hazard. Furthermore, in many areas, interior wall and ceiling finishes have been removed exposing the wood walls and ceilings; therefore, increasing the threat and spread of fire. Staff was informed that the gas service to the building is disconnected (staff did not verify). (Pictures 1 through 16)

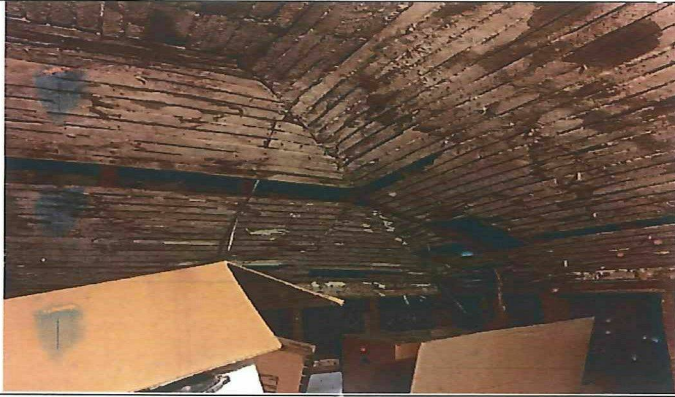
Picture 7

Ceilings in the second story rooms are deteriorated and could potentially detach or dislodge during a moderate or strong earthquake. Based on the current condition, the rooms are not safe for occupancy. (Photos 7 & 9)
