CHULA VISTA SEARS

City of Chula Vista
City Council
June 10, 2014

Sears Building – 565 Broadway

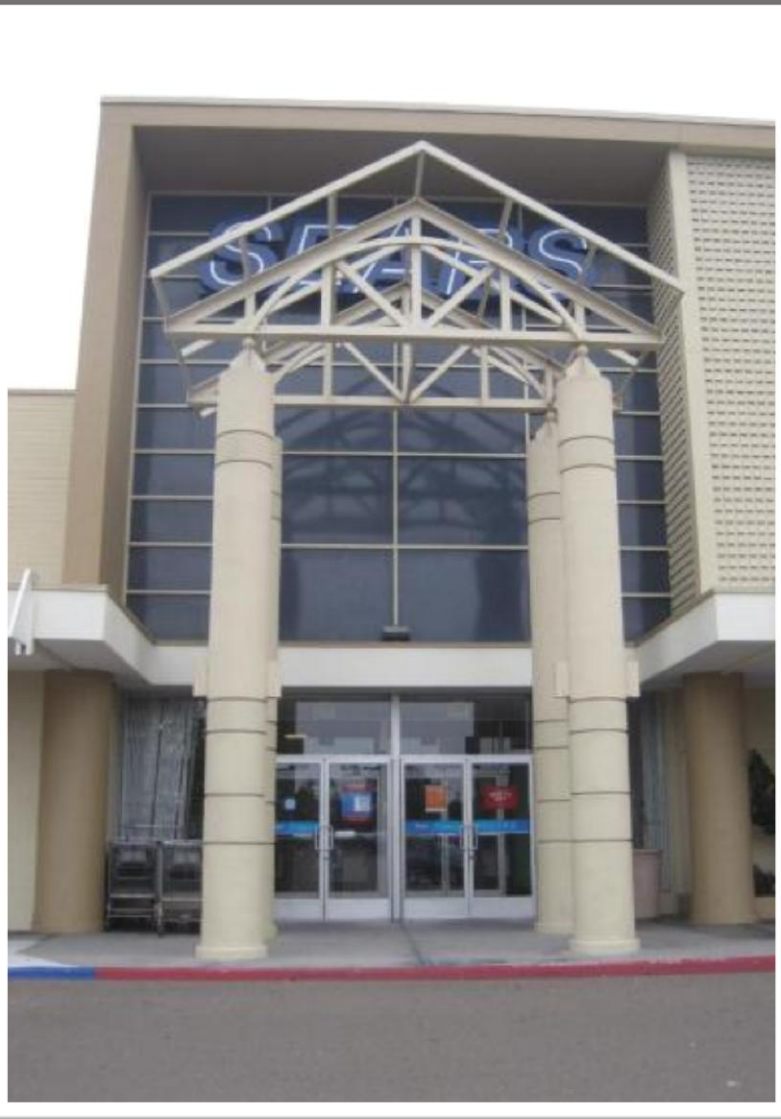
North Elevation

Structure is not attached to the Building in North location

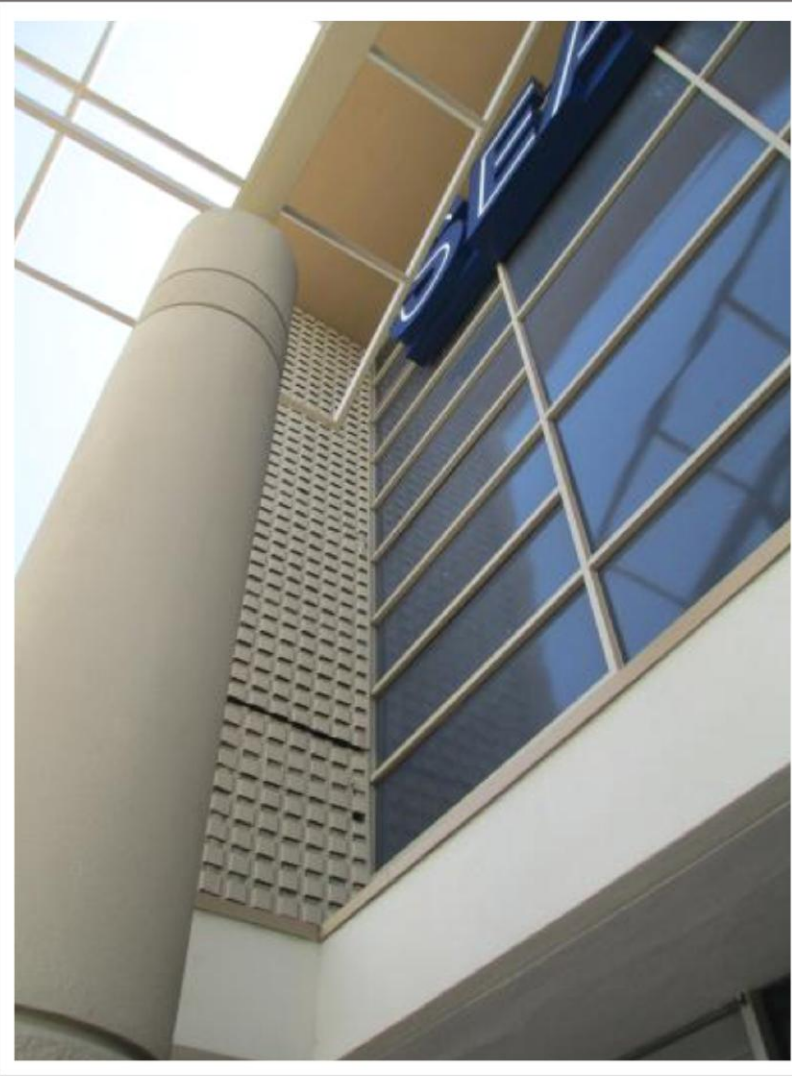
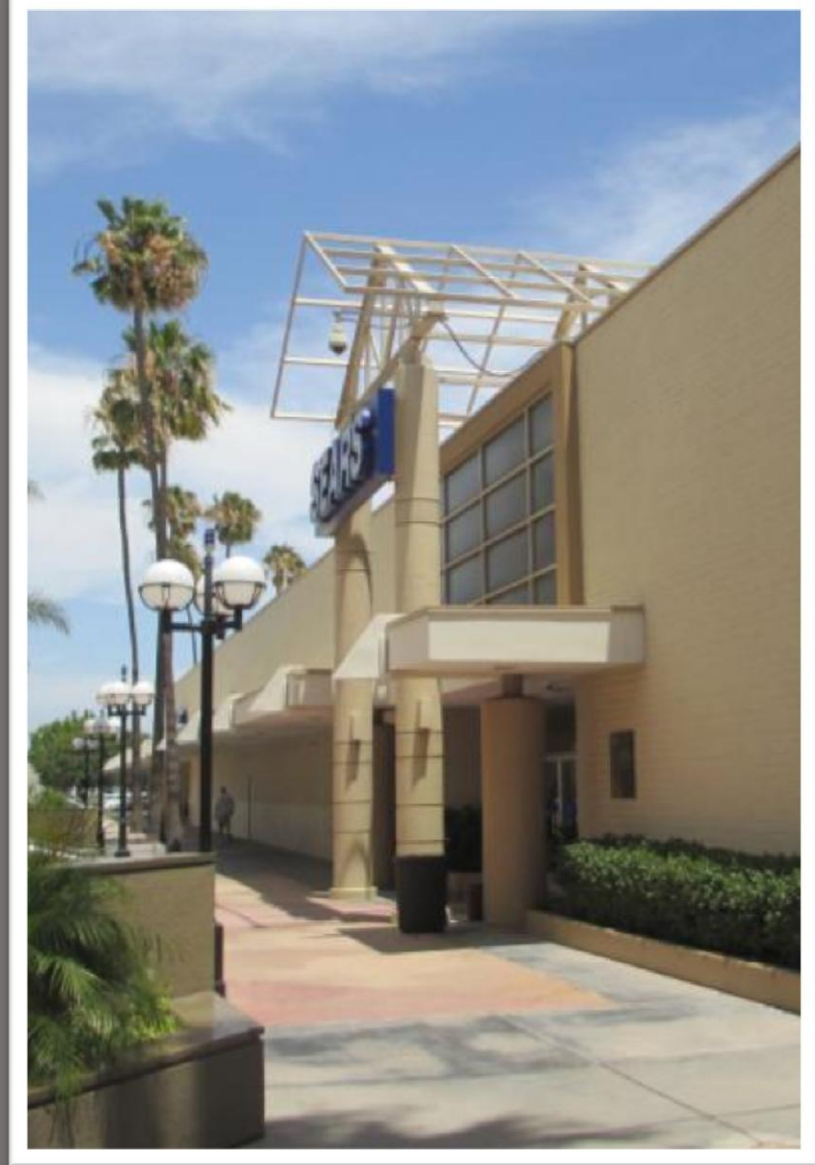
Structure is attached to the roof-top building in West location

Columns are covered with a hollow encasement

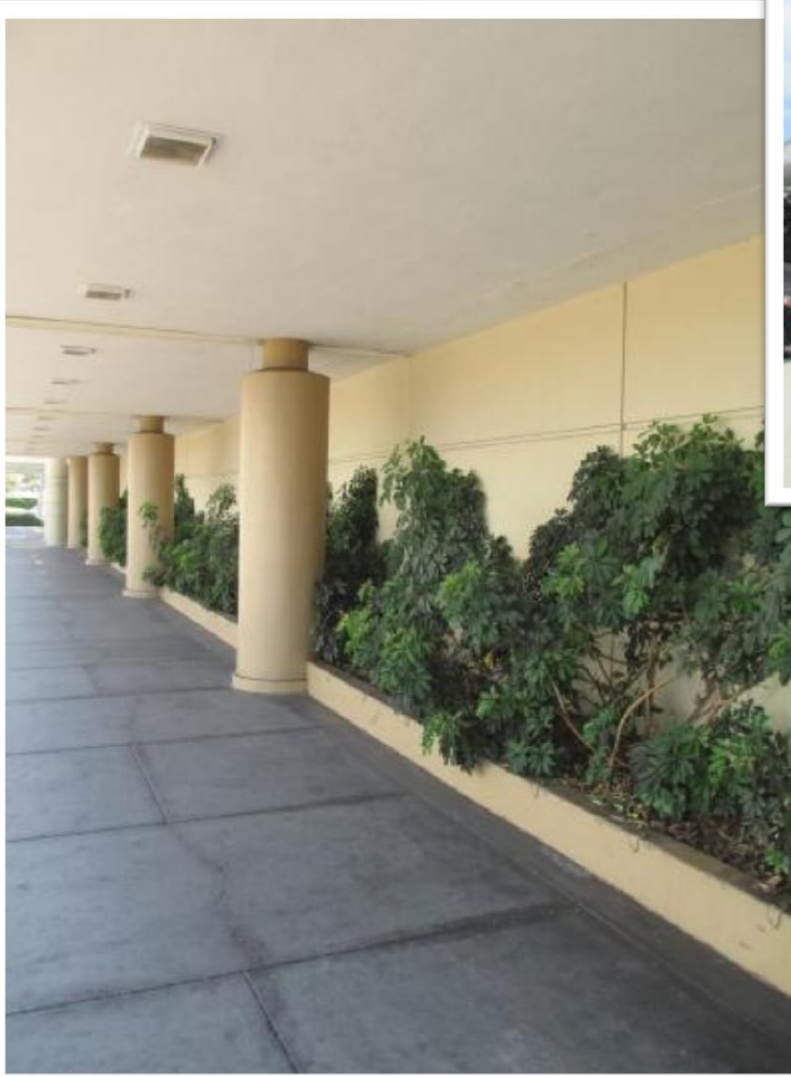
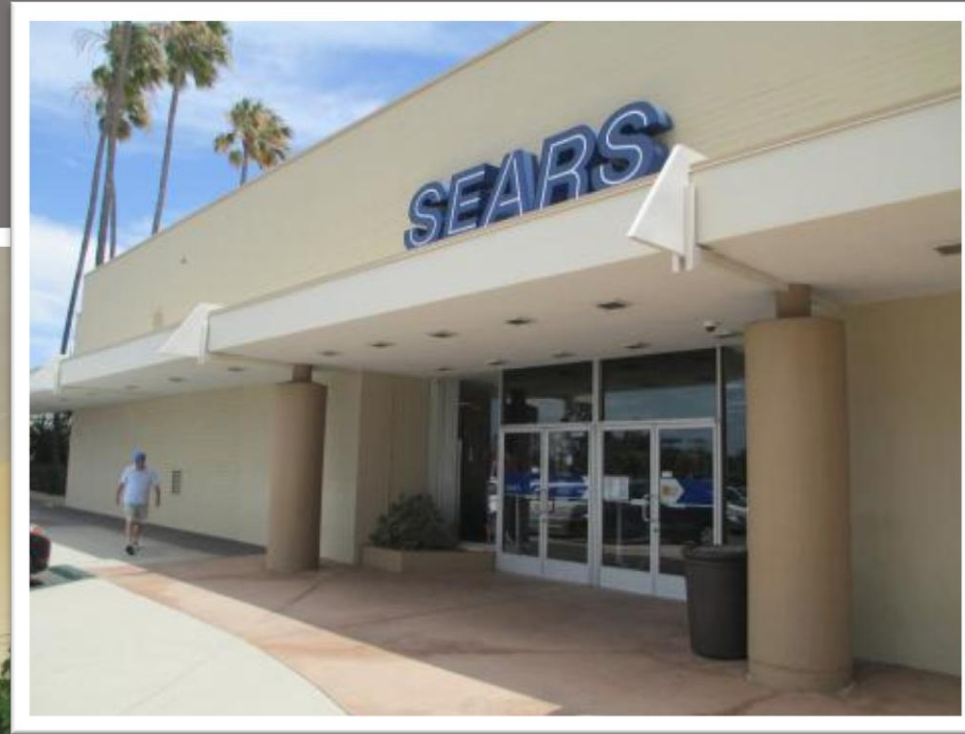
Storefront display windows are obscured.

Ephemeral conjectural
Feature added
Every 26'-0"
