**REPORT ON POST-PROJECT TREE RETAINABILITY:
CIP STM-382, EAST H STREET PROJECT
PREPARED FOR MR. GREGORY E. TSCHERCH**

**BY SAM OLUDUNFE
ISA #WE-8574AUM; ISA TRAQ**

NOV 2015

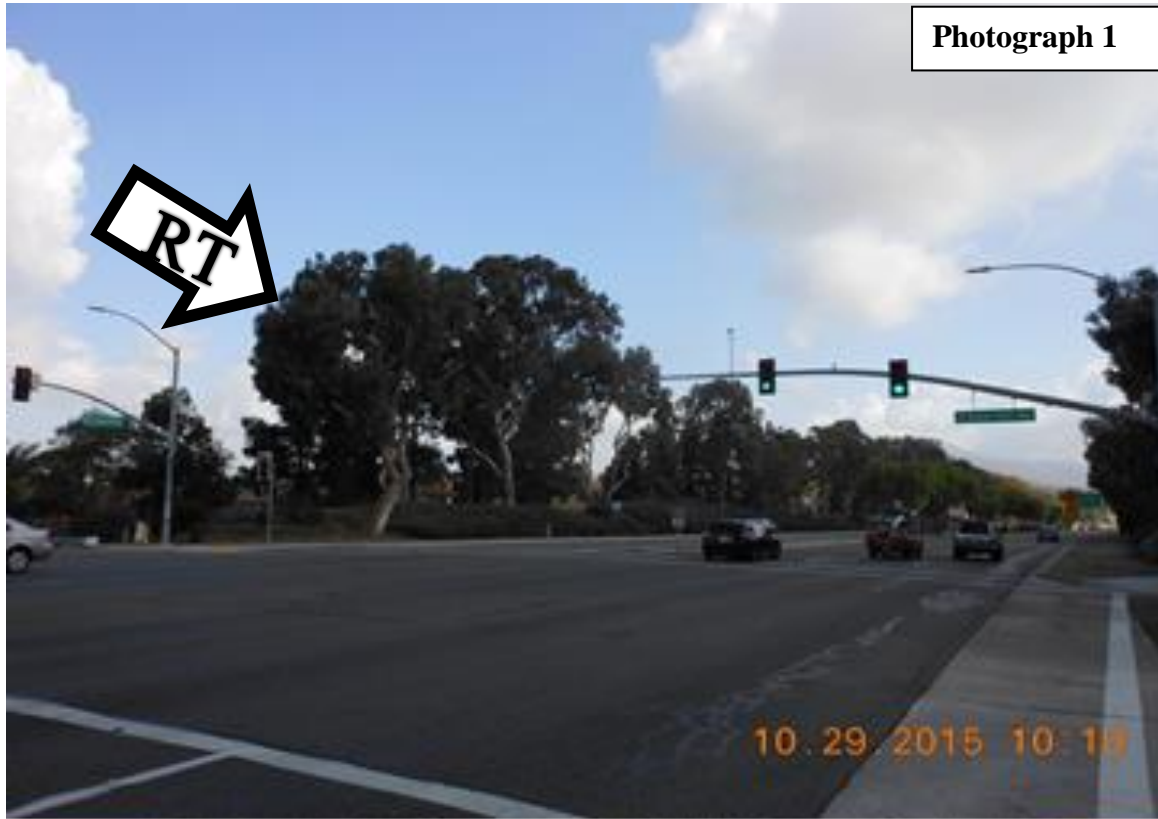
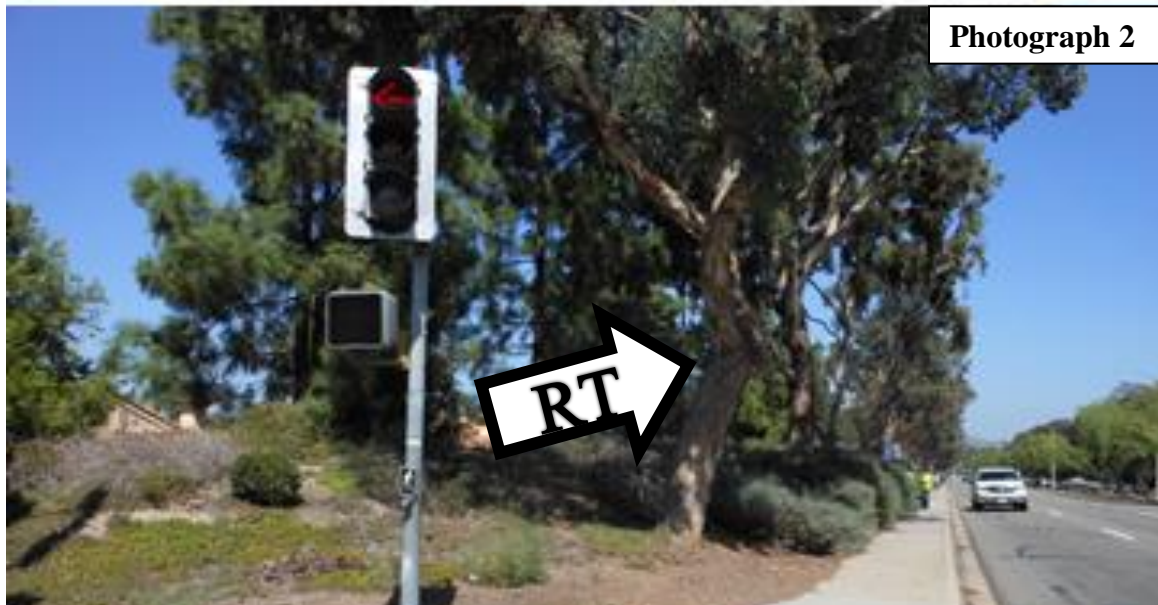
The mixed species eucalyptus trees under discussion are mostly river red gums (*Eucalyptus camaldulensis*), silver dollar gums (*Eucalyptus polyanthemos*), and sugar gums (*Eucalyptus cladocalyx*) which were planted in the mid-1970s to flank East H Street. Subsequent road widening exercises on East H Street over the years have moved the roadways very close to the trees (photographs 1 to 4, 6 to 8).

Photographs 1 (top; taken from the southwest side of East H Street and Buena Vista Way intersection, facing northeast) and 2 (above; taken from the west side of intersection, facing east) show a section of subject East H Street eucalyptus trees. Representative tree (RT), measured at 25 inches dsh, is arrowed in Photos 1 and 2.

I recommend that any of the eucalyptus trees whose major roots (larger than two inches in diameter) are severed within ten feet of the tree's trunk be removed to prevent injury to persons and damage to property in the event of such a tree's failure.

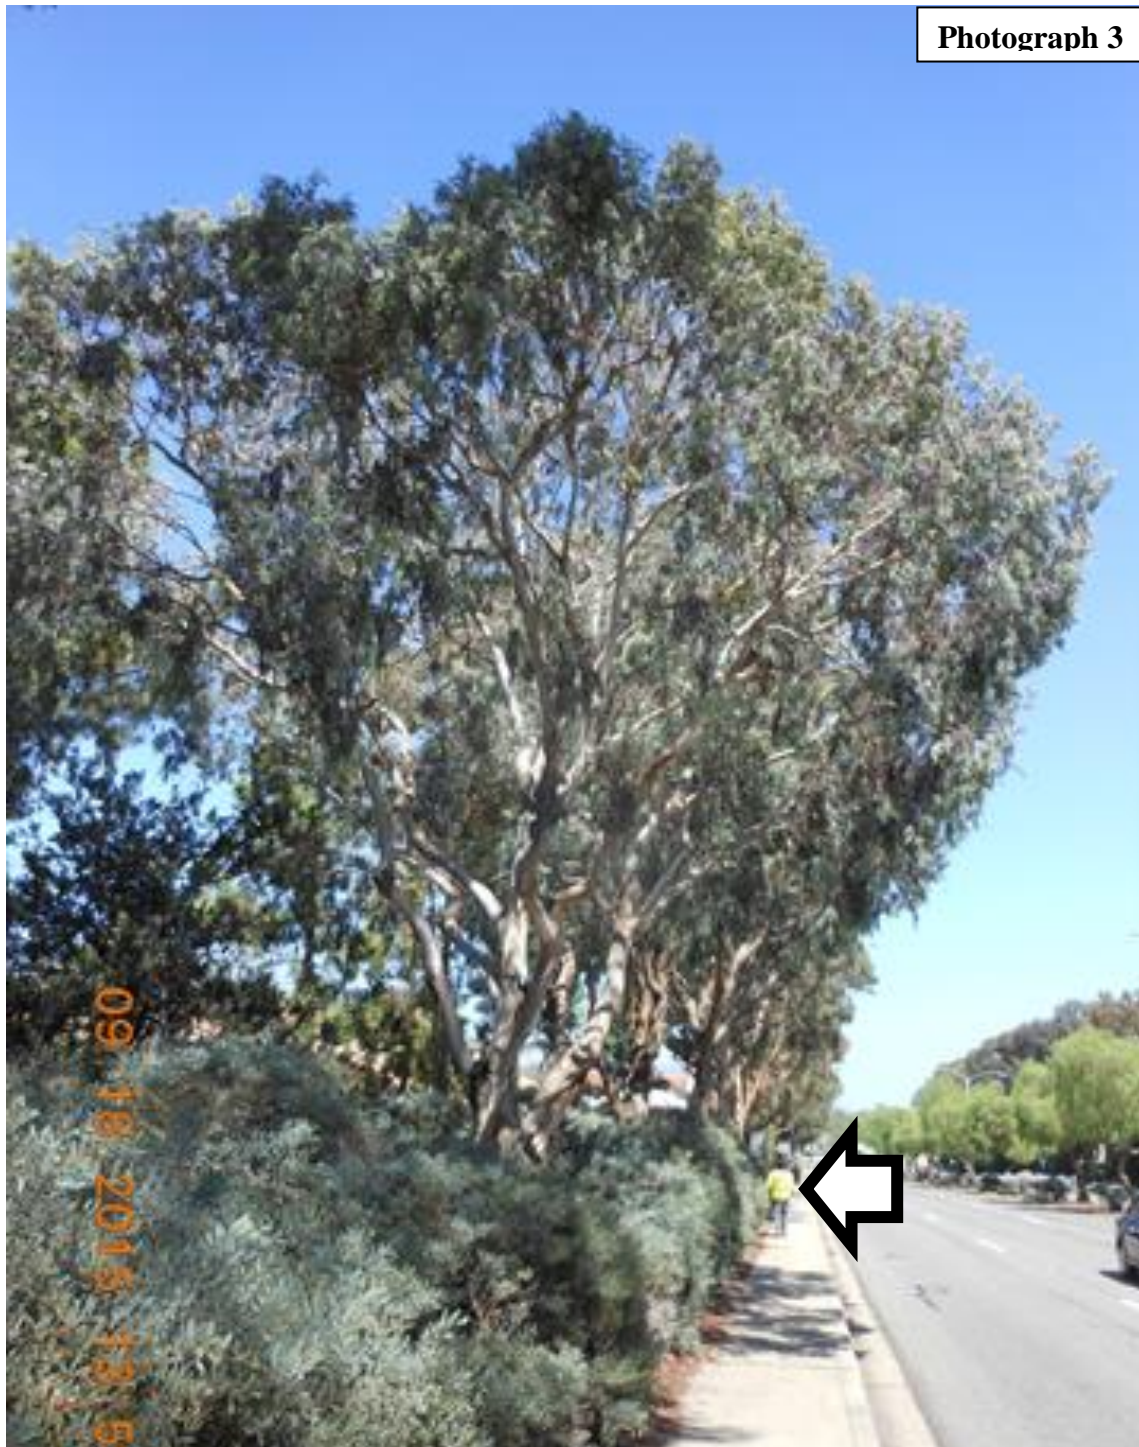
The eucalyptus trees I inspected on East H Street range from 35 feet to 60 feet in height; I recorded a 25-inch dsh on the representative eucalyptus tree I measured at the northeast corner of East H Street and Buena Vista Way. I observed that most of the eucalyptus trees looked very healthy; there were no noticeable evidence of disease or insect infestations on the trees.

Photograph 3 – A view of subject East H Street eucalyptus trees. Note the full height (estimated at 60 feet) of some of the trees in relation to the height (6 feet) of an adult man (arrowed). Photograph 3 was taken from the west, facing east.

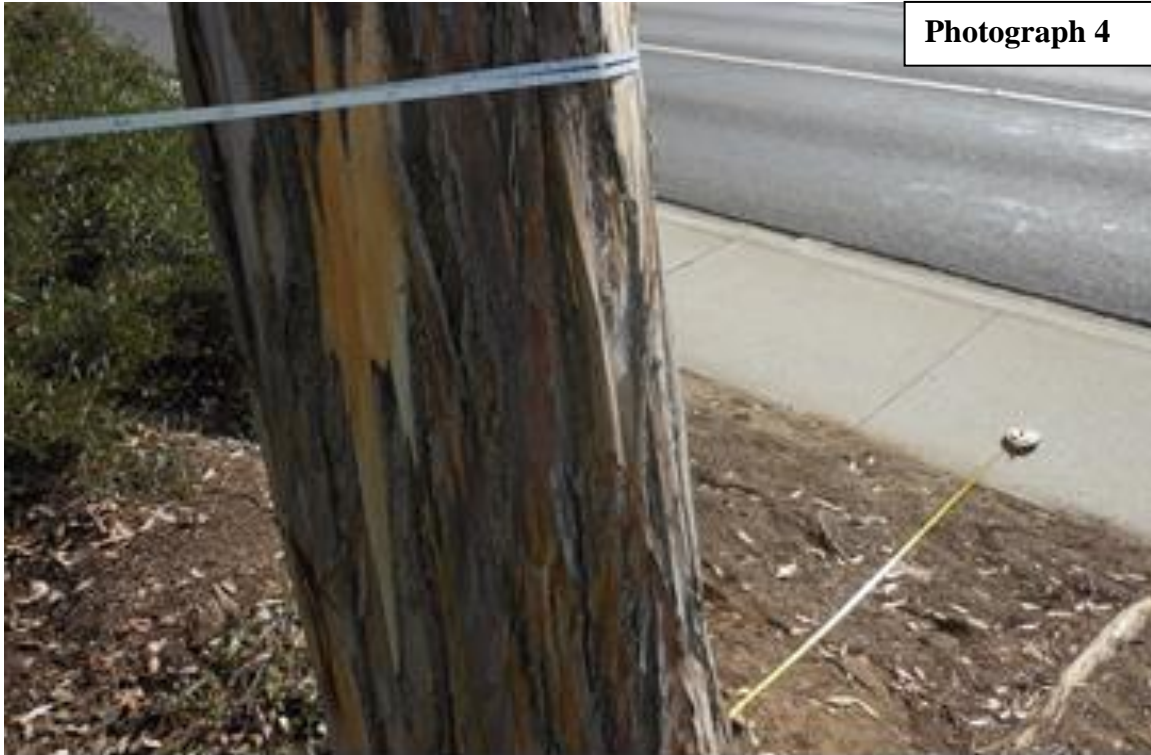
Photograph 4

standard height (dsh) of a representative eucalyptus tree located at the northeast corner of East H Street and Buena Vista Way (photographs 4 and 5). I used a tape measure to measure the distance from the base of the representative tree to the back of the adjacent sidewalk (photograph 6). I took several photographs of the trees and the site (photographs 1 to 8). I did not perform any aerial inspection of the trees' **crowns** at any time; I did not conduct any **root crown** excavation, either.

Photographs 4 and 5 – Representative tree measured 25 inches dsh.

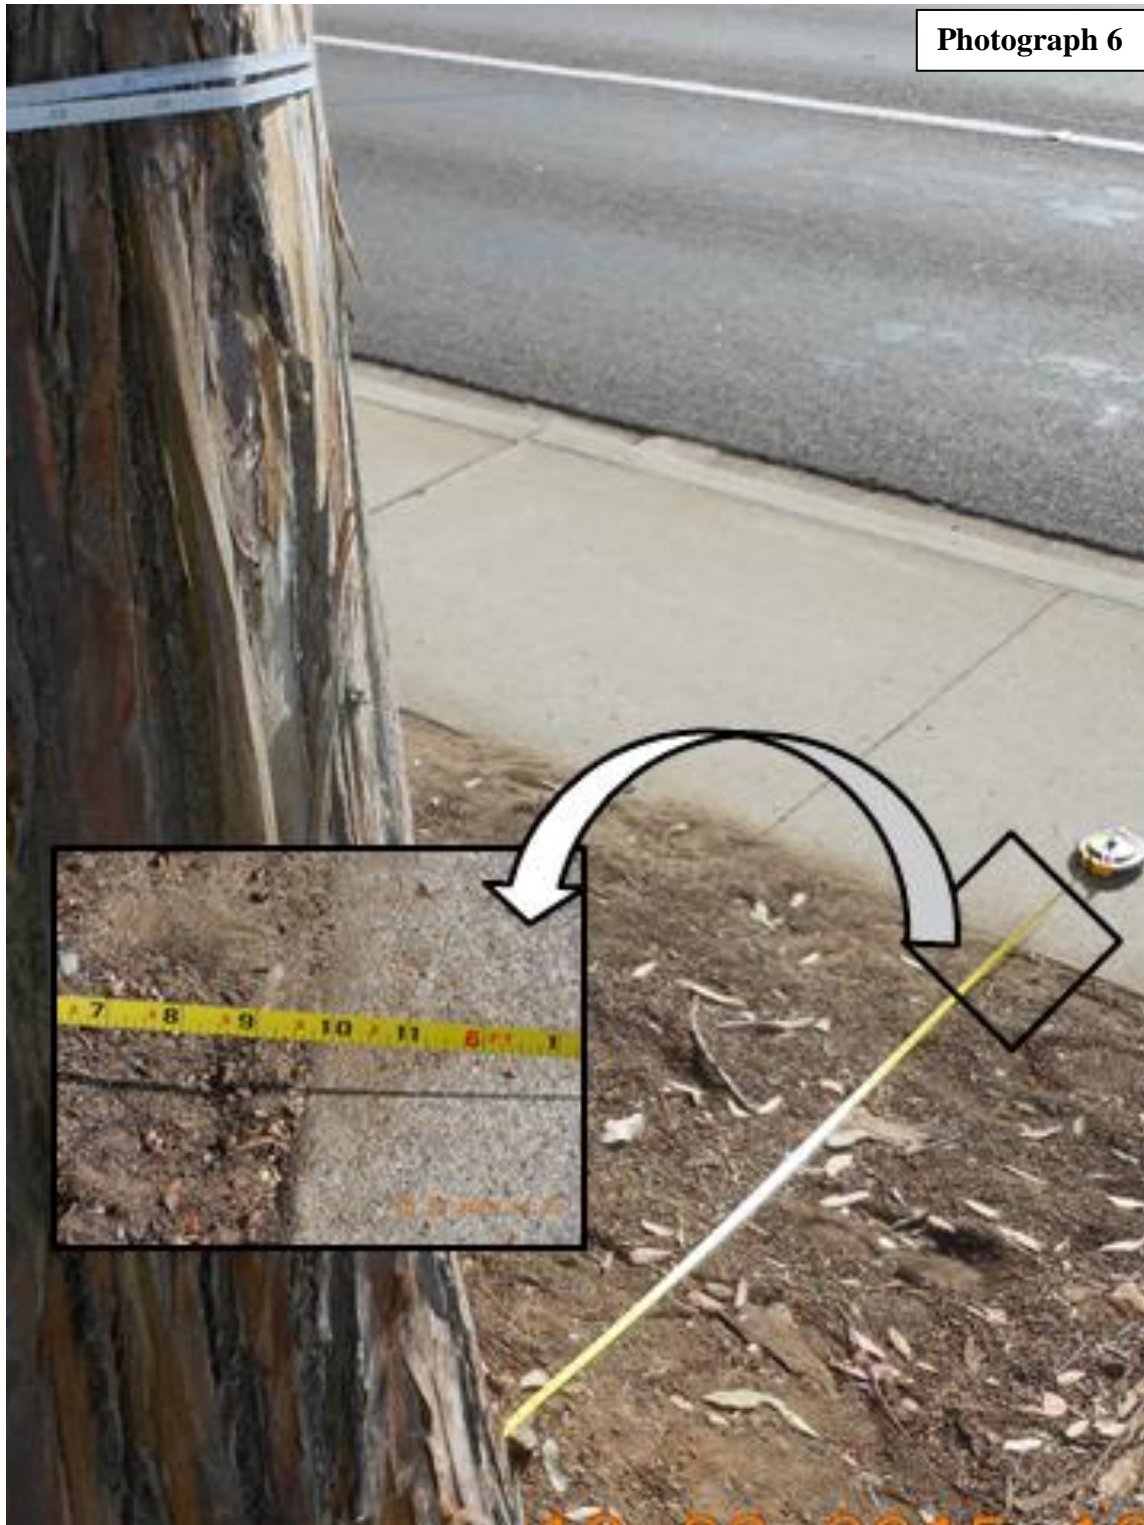
Road widening exercises on East H Street over the years have moved the roadways very close to the large eucalyptus trees: many of the trees are located within a distance of six feet from the adjacent sidewalk (photographs 6 to 8).

Photograph 6 – Representative tree (25 inches dsh, 60 feet height) is located 5 feet 10 inches from the adjacent sidewalk.

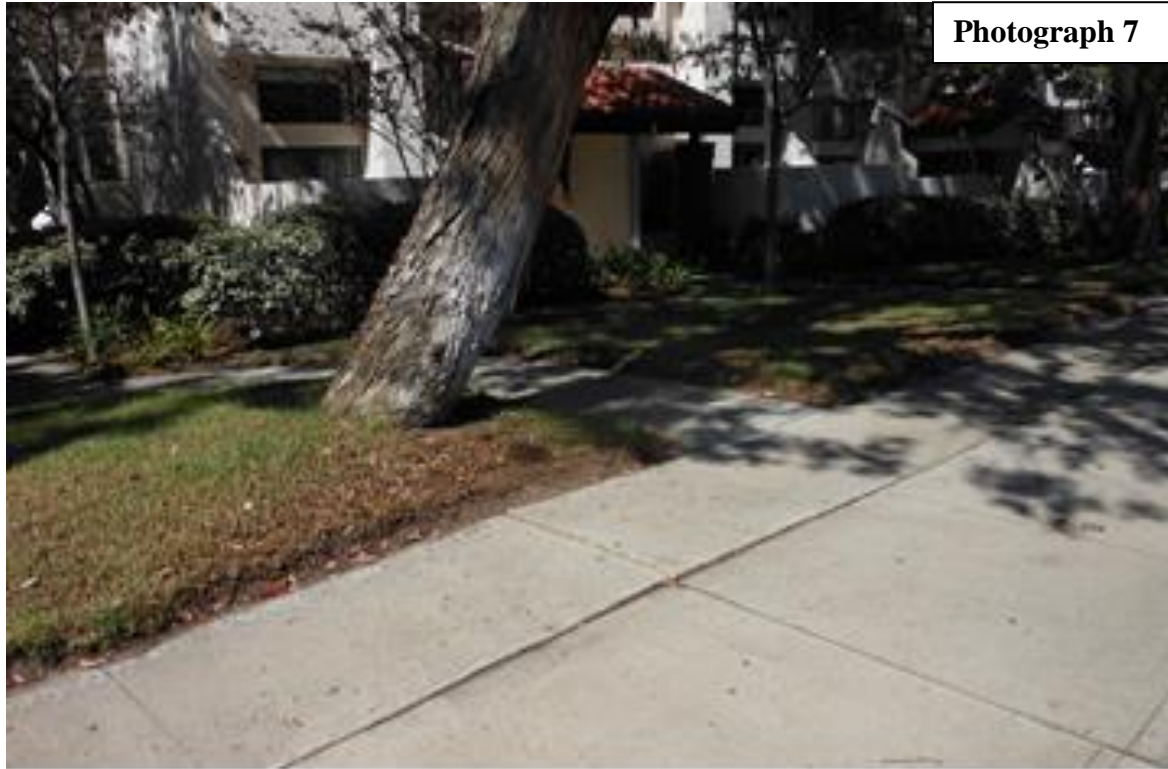
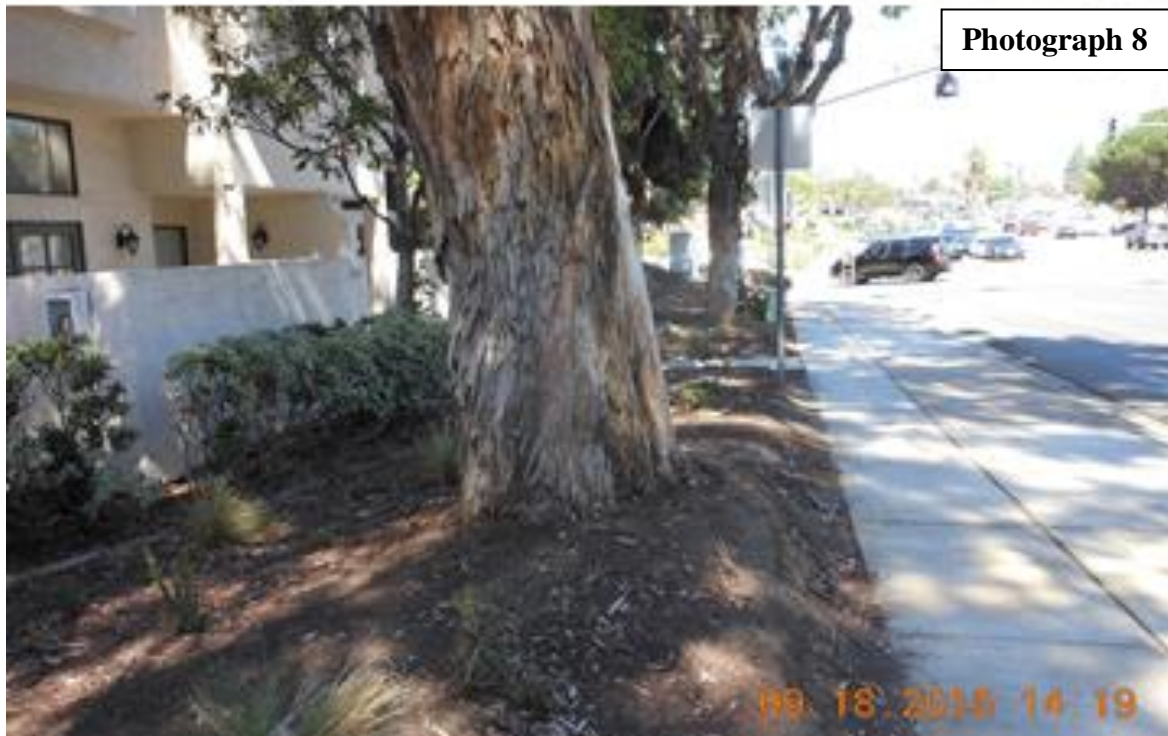
Photographs 7 (top) and 8 (above) show a section of subject East H Street eucalyptus trees and their proximity to the adjacent sidewalk. The trees are located less than three feet from the adjacent sidewalk.
