565 Broadway

Continuation Update

State of California — The Resources Agency
 DEPARTMENT OF PARKS AND RECREATION
PRIMARY RECORD

2012 Survey DPR

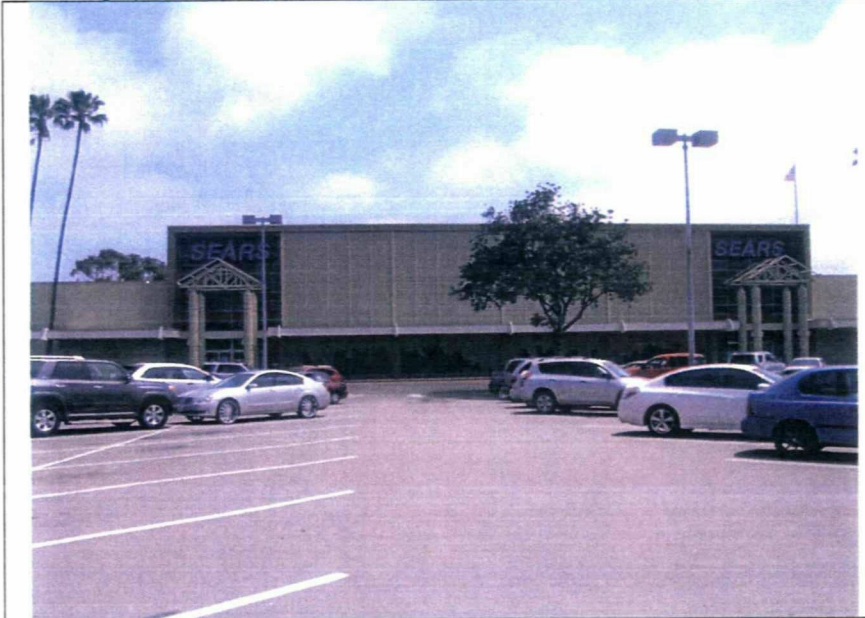
P5a. Photograph or Drawing (Photograph required for buildings, structures, and objects.)

565 Broadway was constructed circa 1960 in the Modern non-residential style. It is a one- and two-story department store building located on the south side of Broadway between Fig and Fifth avenues. The commercial building has a steel frame, L-shaped floor plan with a concrete and steel foundation. The exterior is clad in scored and patterned concrete siding. The roof is flat. On the north elevation, there are two glass and metal storefronts with multiple entrance doors. There is also a covered walkway that surrounds the building. Decorative features of the building include a concrete screen on the north façade that is flanked by large fixed glass windows. At the south elevation there is a scalloped porch roofline that covered the entrances. Additions include a one-story addition on the south façade, two ornamental structures at the entrances of the north elevation. Modifications to the building include the additions. Landscape features include small trees and bushes along the exterior walkway and a large parking lot surrounding the lot. The building is part of the large shopping mall located to the west of the building.

View looking south at the building.

Photo taken on May 11, 2012.
