CHULA VISTA SEARS

EXPERT TECHNICAL ANALYSIS REPORT

565 BROADWAY, CHULA VISTA, CALIFORNIA

MAY 24, 2013

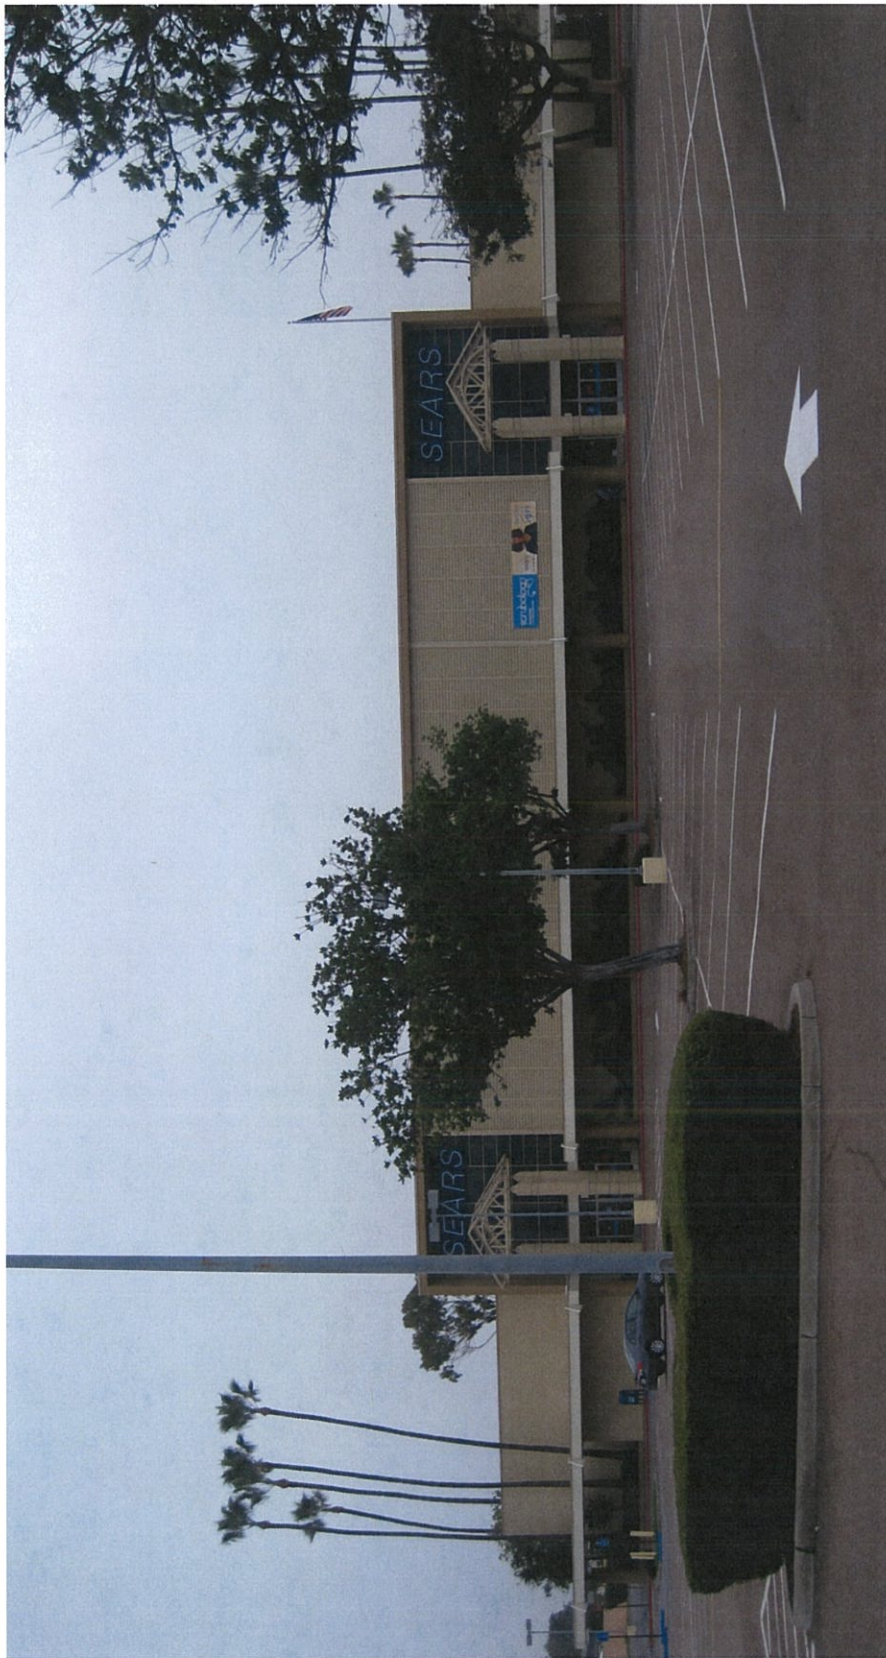
Figure 2-1: Looking south at the primary façade.

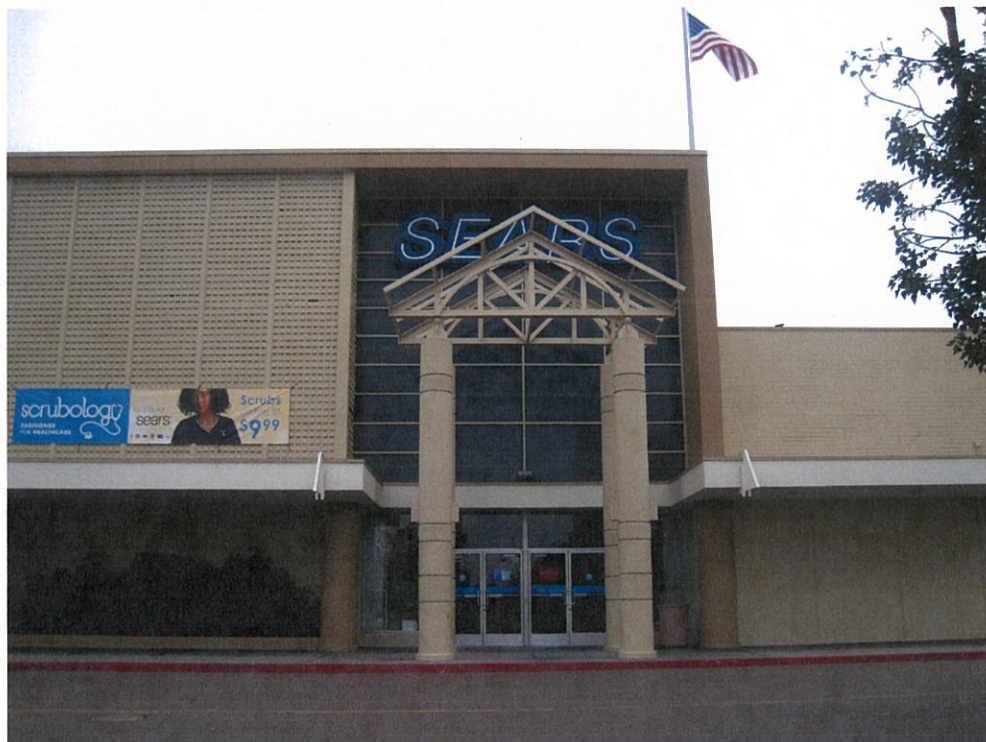
Figure 2-3: View of renovated entry at the north façade with contemporary signage and original large charcoal gray Mirawal panels. The entry canopy has been notched at the storefront entry for the 1980s open-frame gabled canopies.

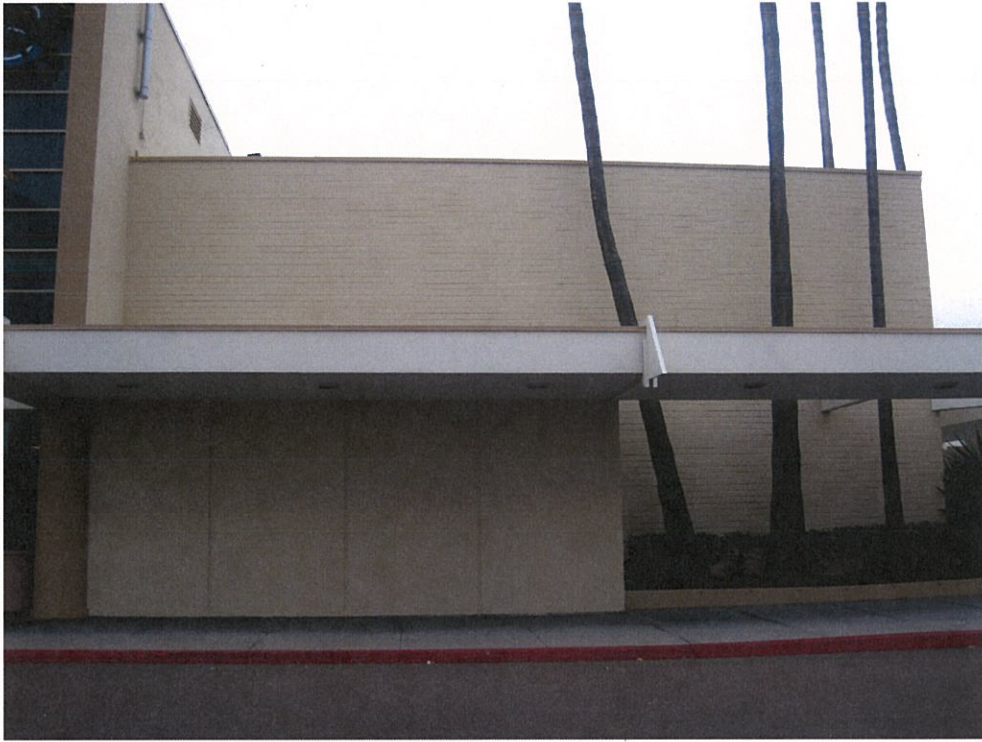
Figure 2-4: Detail of original storefront display windows (now enclosed) and planters at the northwest corner.

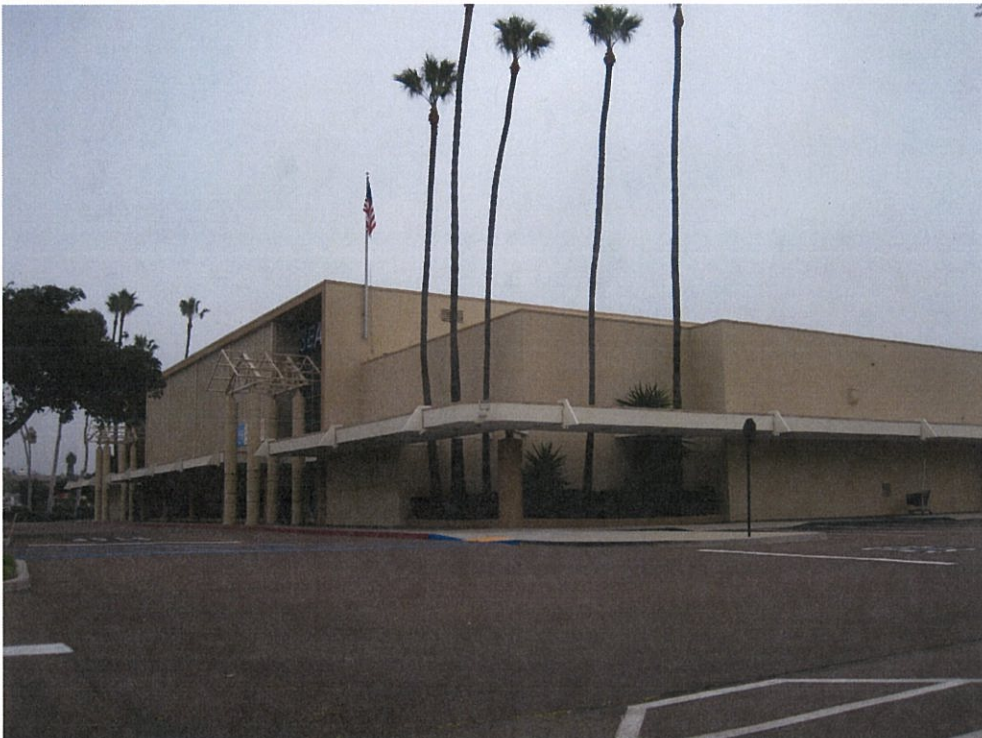
Figure 2-5: Looking southeast at the Chula Vista Sears building.

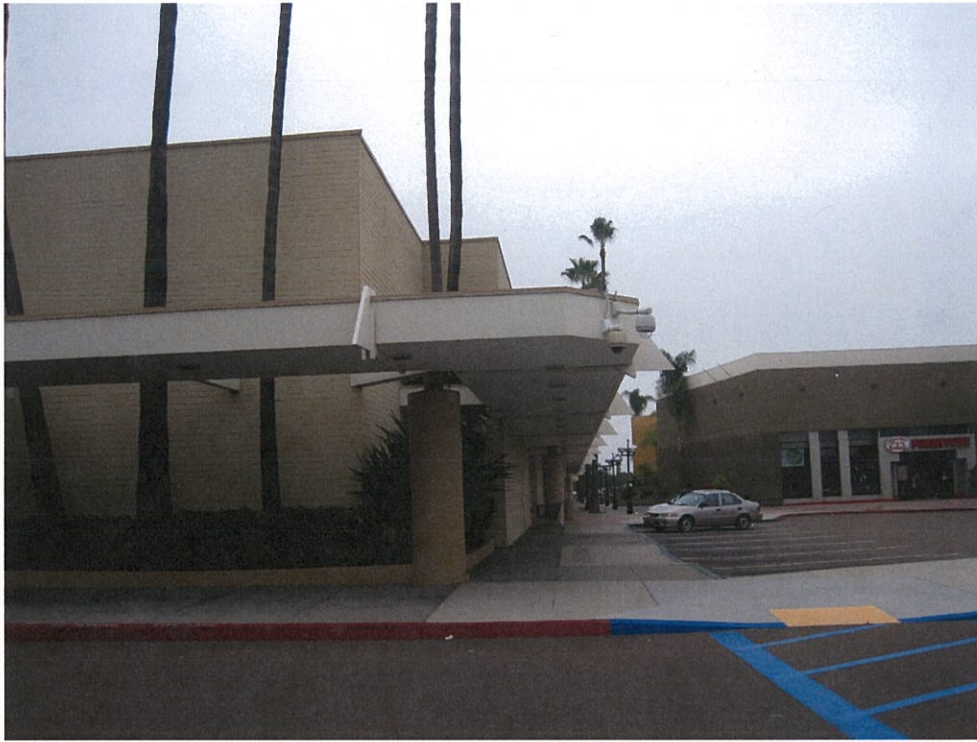
Figure 2-6: Looking south at the covered walkway and the store's relationship to the rest of the shopping center along the now closed Fifth Avenue.

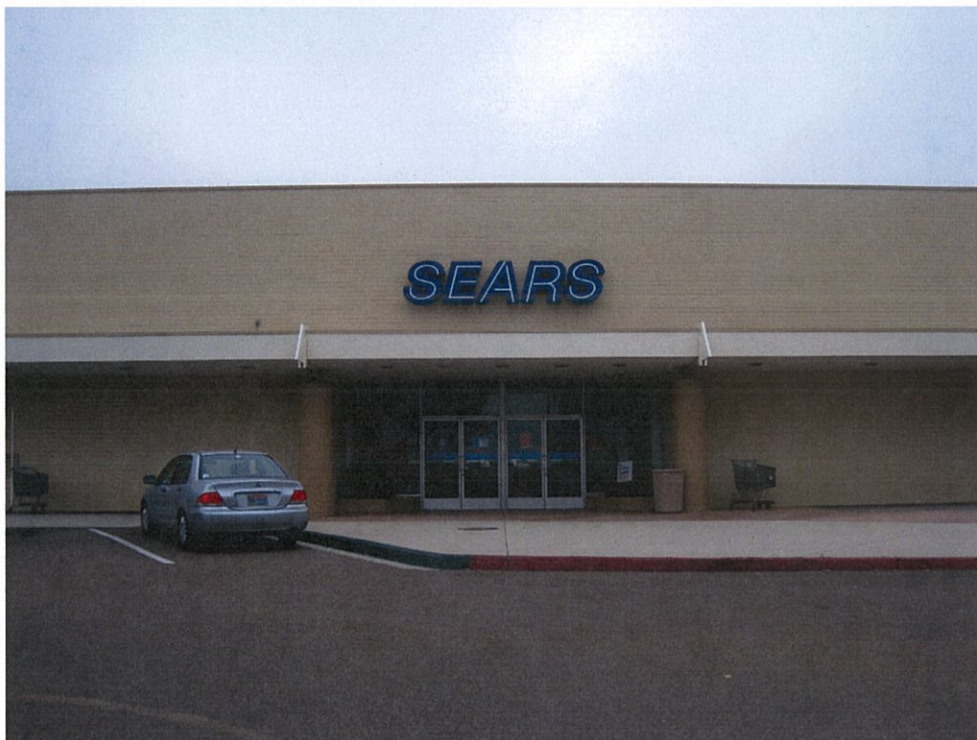
Figure 2-7: Renovated northwest entry with enclosed display windows and contemporary signage.

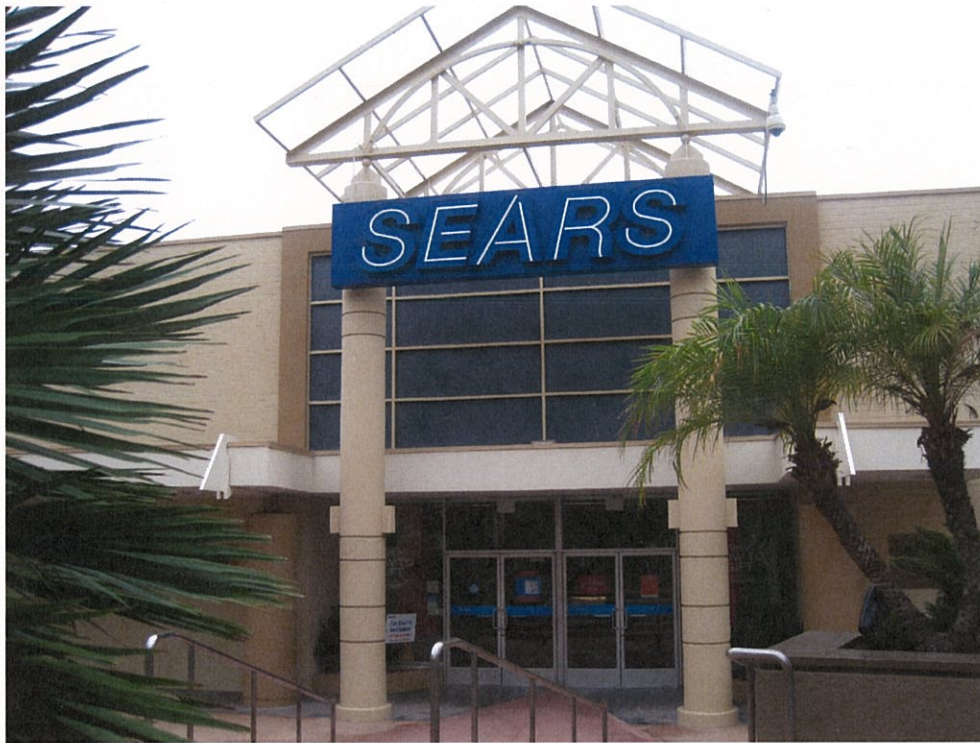
Figure 2-8: Renovated southwest entry showing notched canopy at entry and 1980s open-framed gabled entry structure.

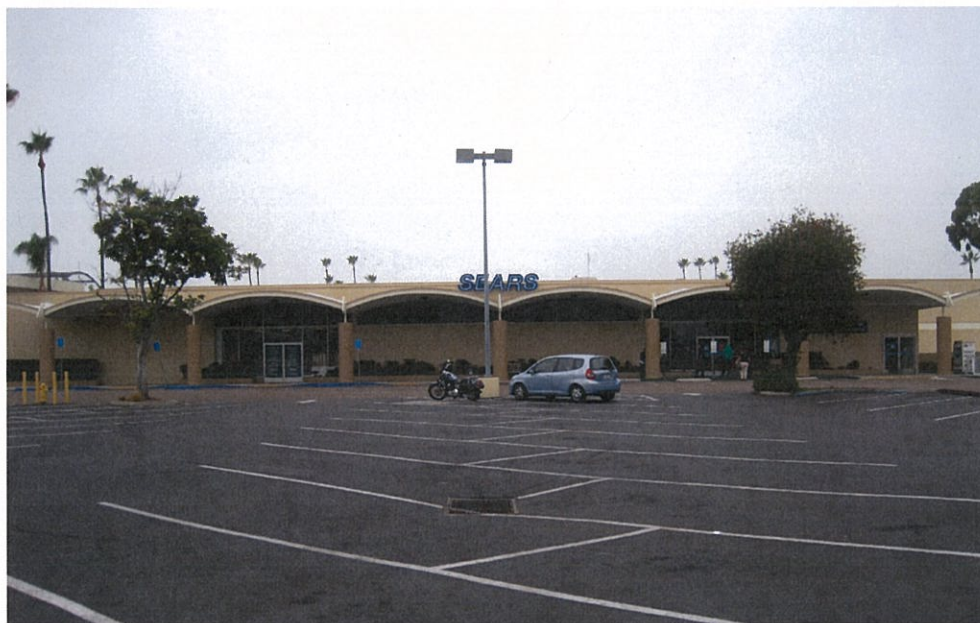
Figure 2-9: Looking north at the south façade. The original Garden Center, located to the left, has been enclosed and its space integrated with the interior retail area.

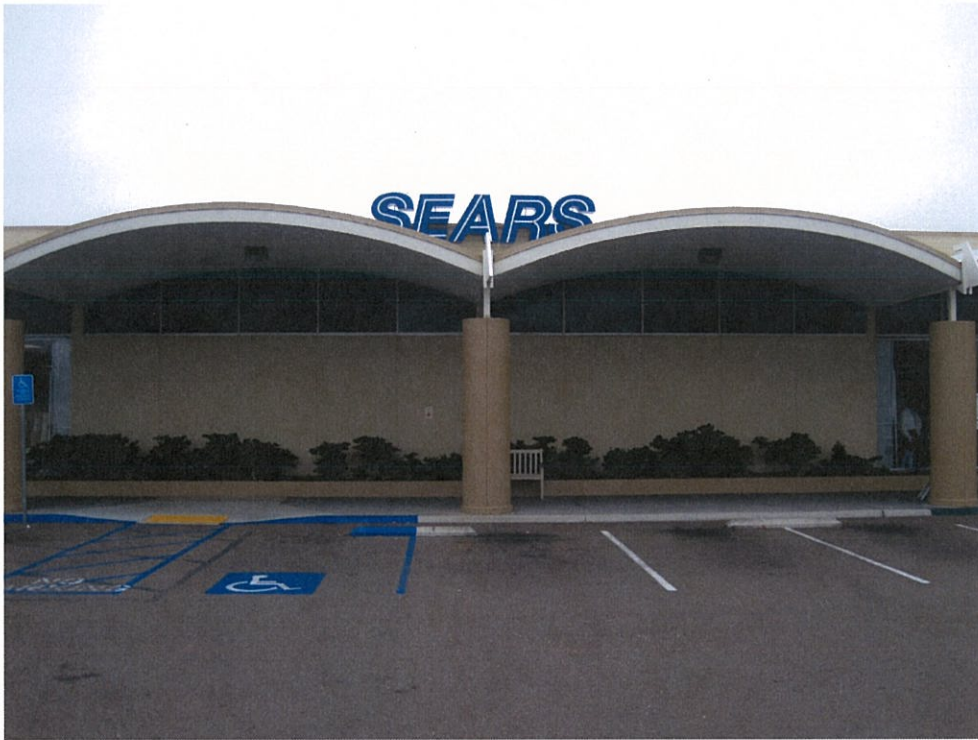
Figure 2-10: Detail of the barrel roof canopy, retrofitted posts, and enclosed original display windows at the south entry.

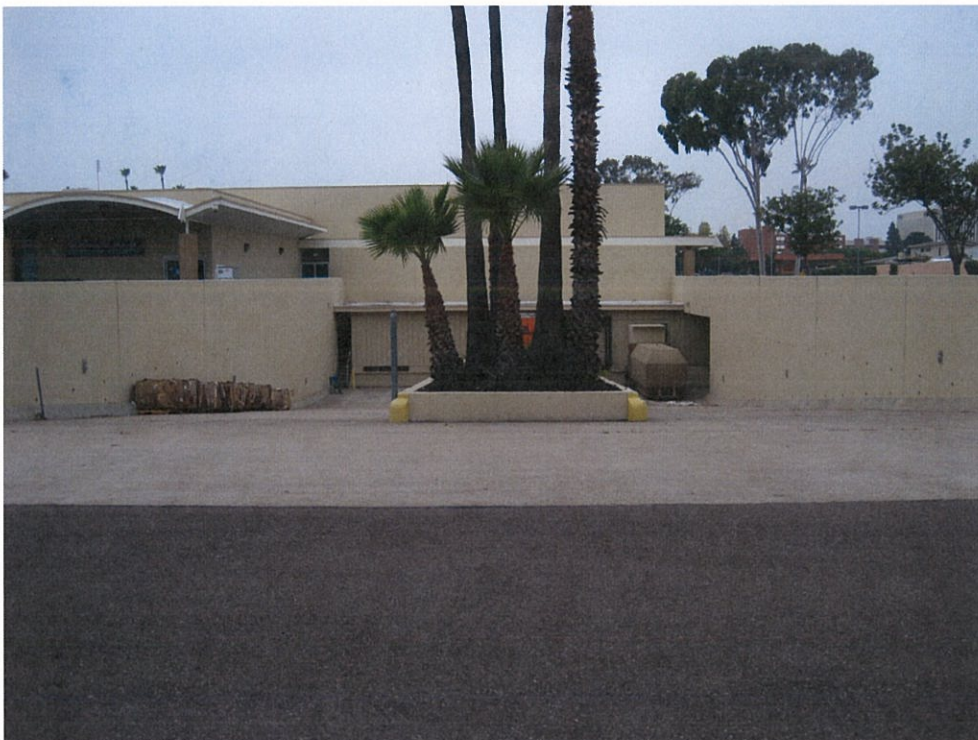
Figure 2-11: View of the original truck ramp with large central planter and loading dock for deliveries at the south façade.

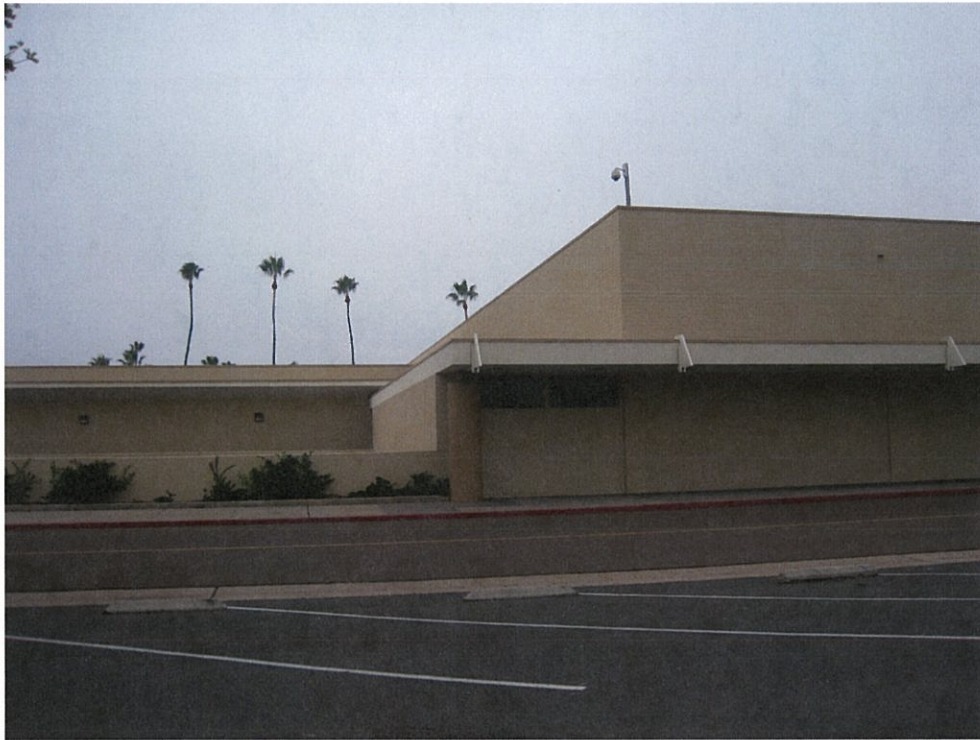
Figure 2-12: Southeast corner showing enclosed walkway.

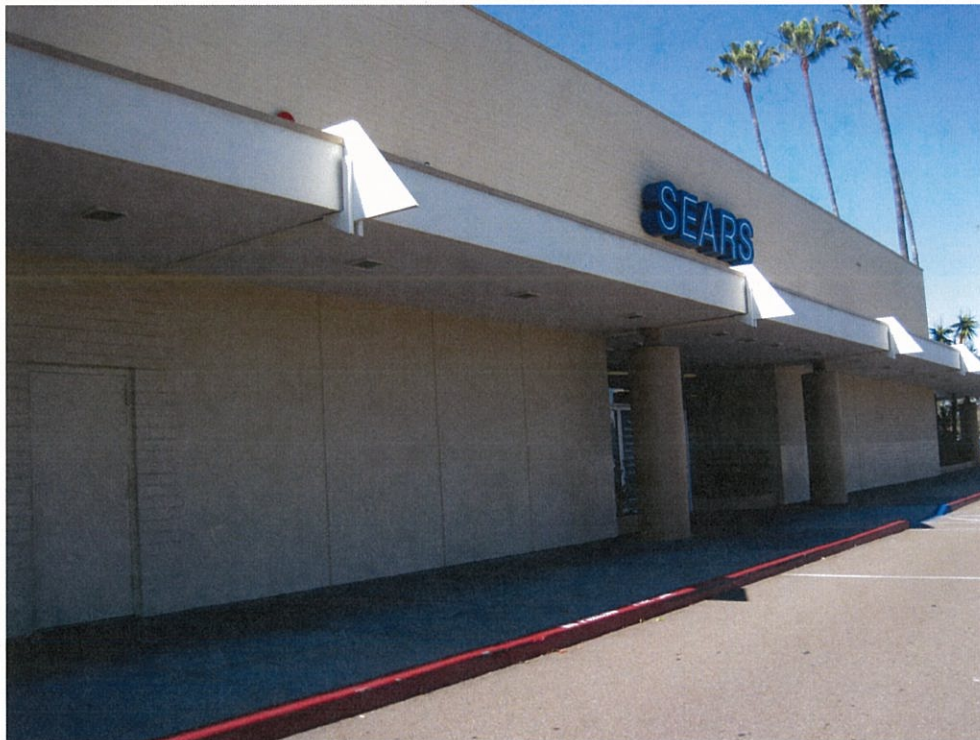
Figure 2-13: East façade showing the enclosed display windows.

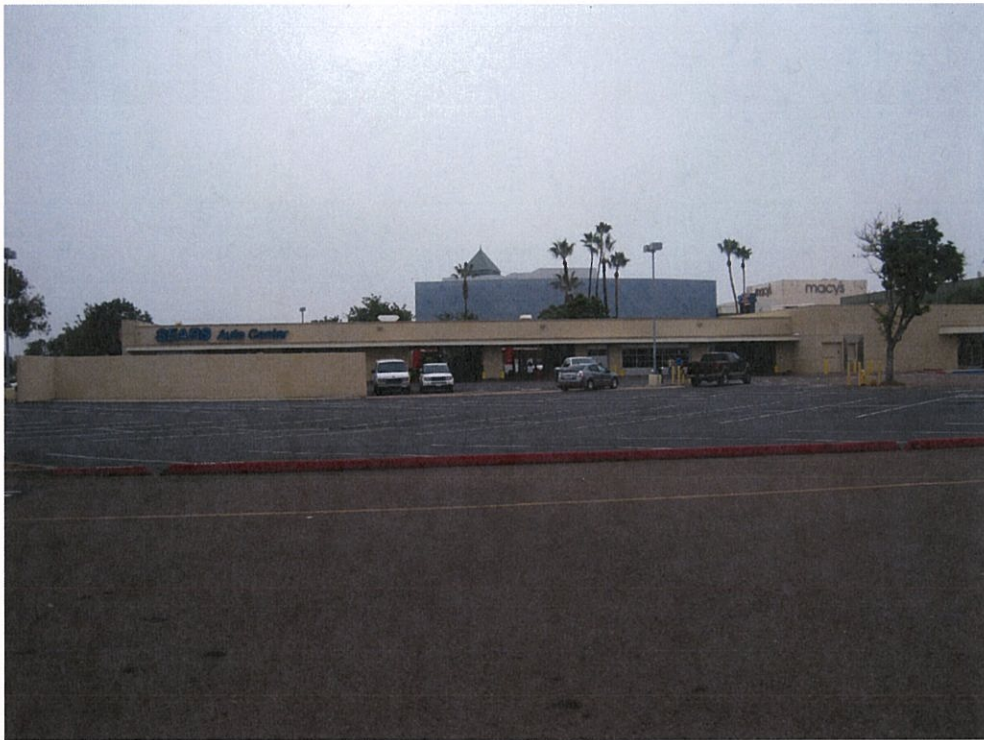
Figure 2-14: Looking west at the Sears Auto Center building.

A separate 1966 Auto Center is located at the southwest portion of the lot. At the time it was originally constructed it boasted the ability to service up to 24 automobiles simultaneously. Similar changes occurred to the Auto Center building throughout the years including the removal of the brick and stone veneer cladding, enclosure of the window displays, and the replacement of the original signage with contemporary signs. The original Gas Pump Island located to the west of the Auto Center was demolished in 1988 as part of the shopping center renovation.

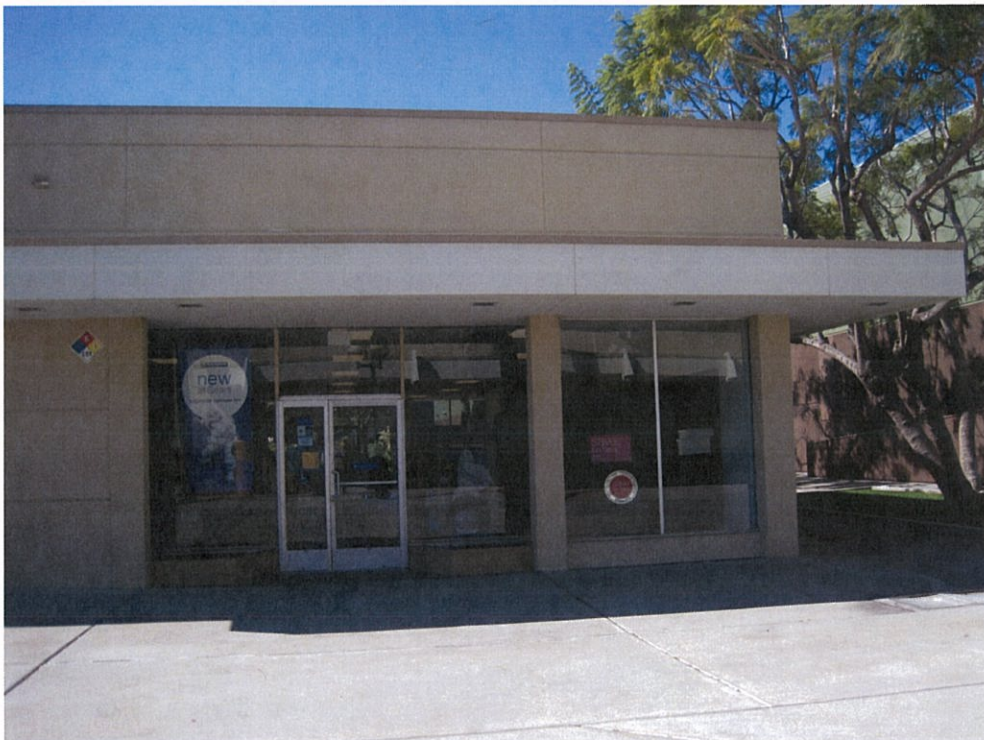
Figure 2-15: Looking west at the Sears Auto Center service entry.

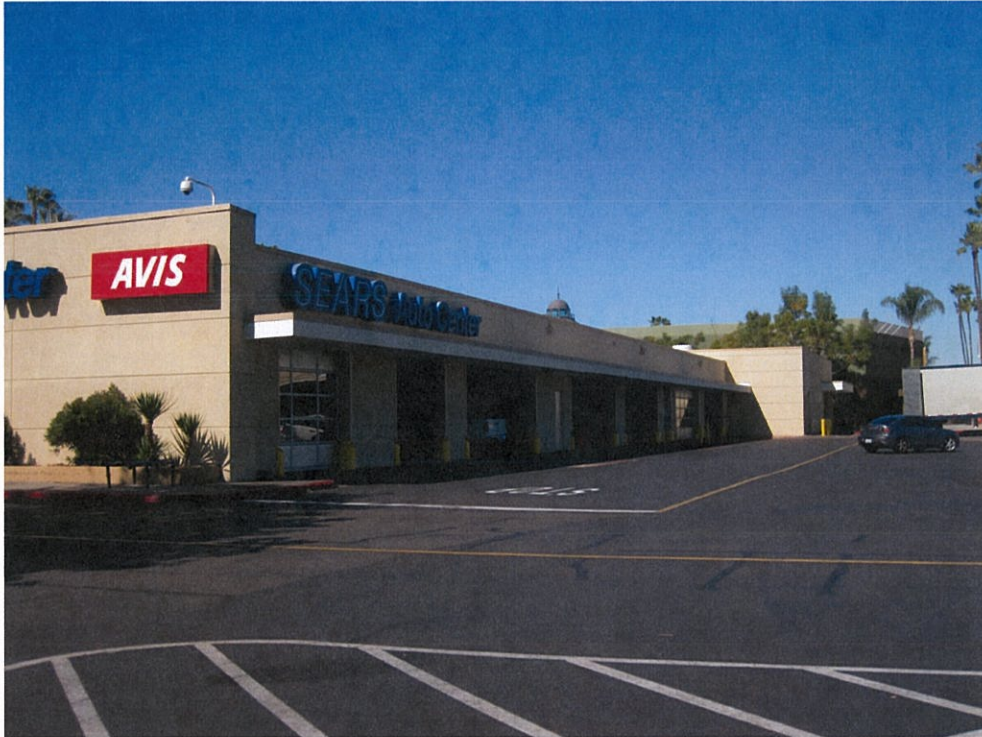
Figure 2-16: Looking northwest at the Sears Auto Center building. All signage has been replaced. The original brick and stone veneer cladding are no longer extant.

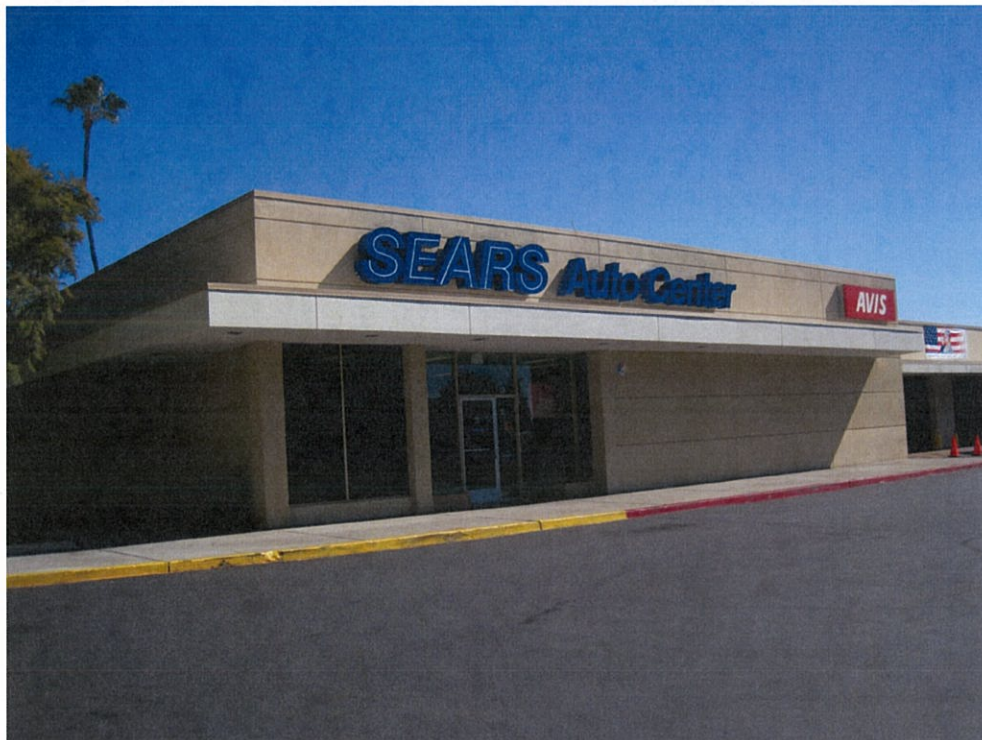
Figure 2-17: Looking southeast at the Sears Auto Center building. The north façade's original storefront windows and original brick wall to the right of the west storefront are no longer extant. All original signage have been replaced with contemporary ones.

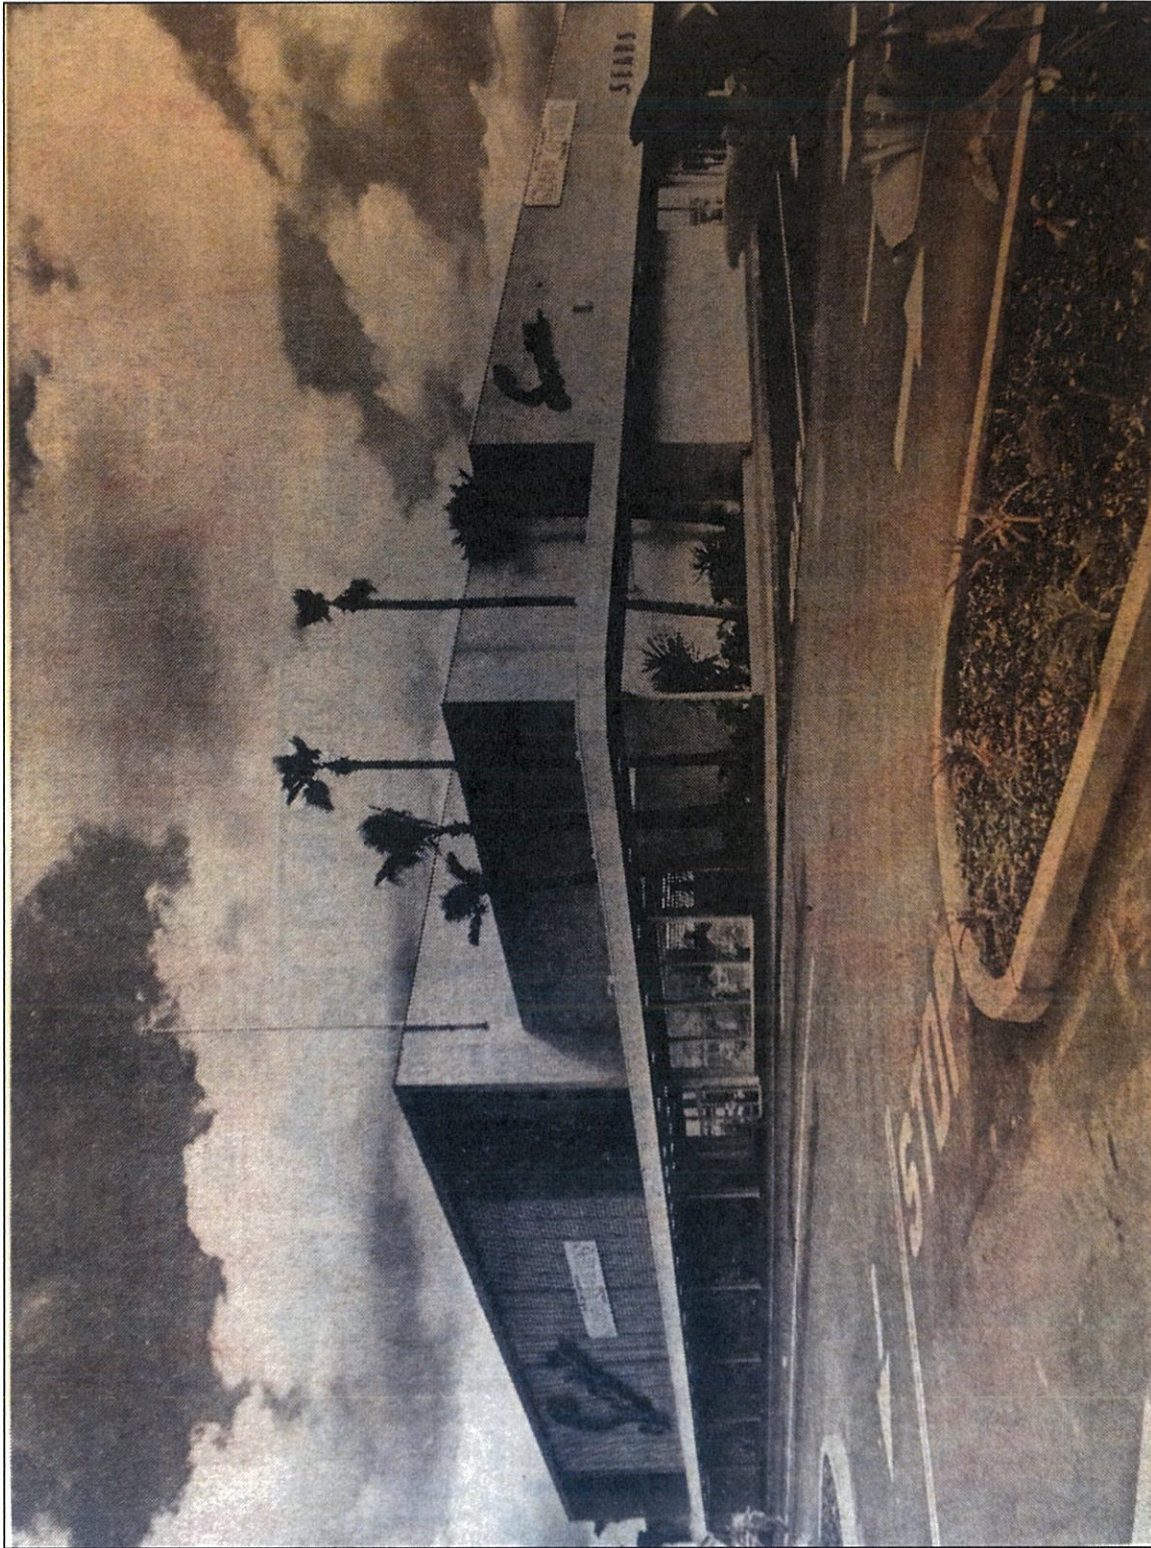
Figure 4-11: Looking southeast at the newly completed Chula Vista Sears. Source: *Chula Vista Star-News* February 20, 1966.

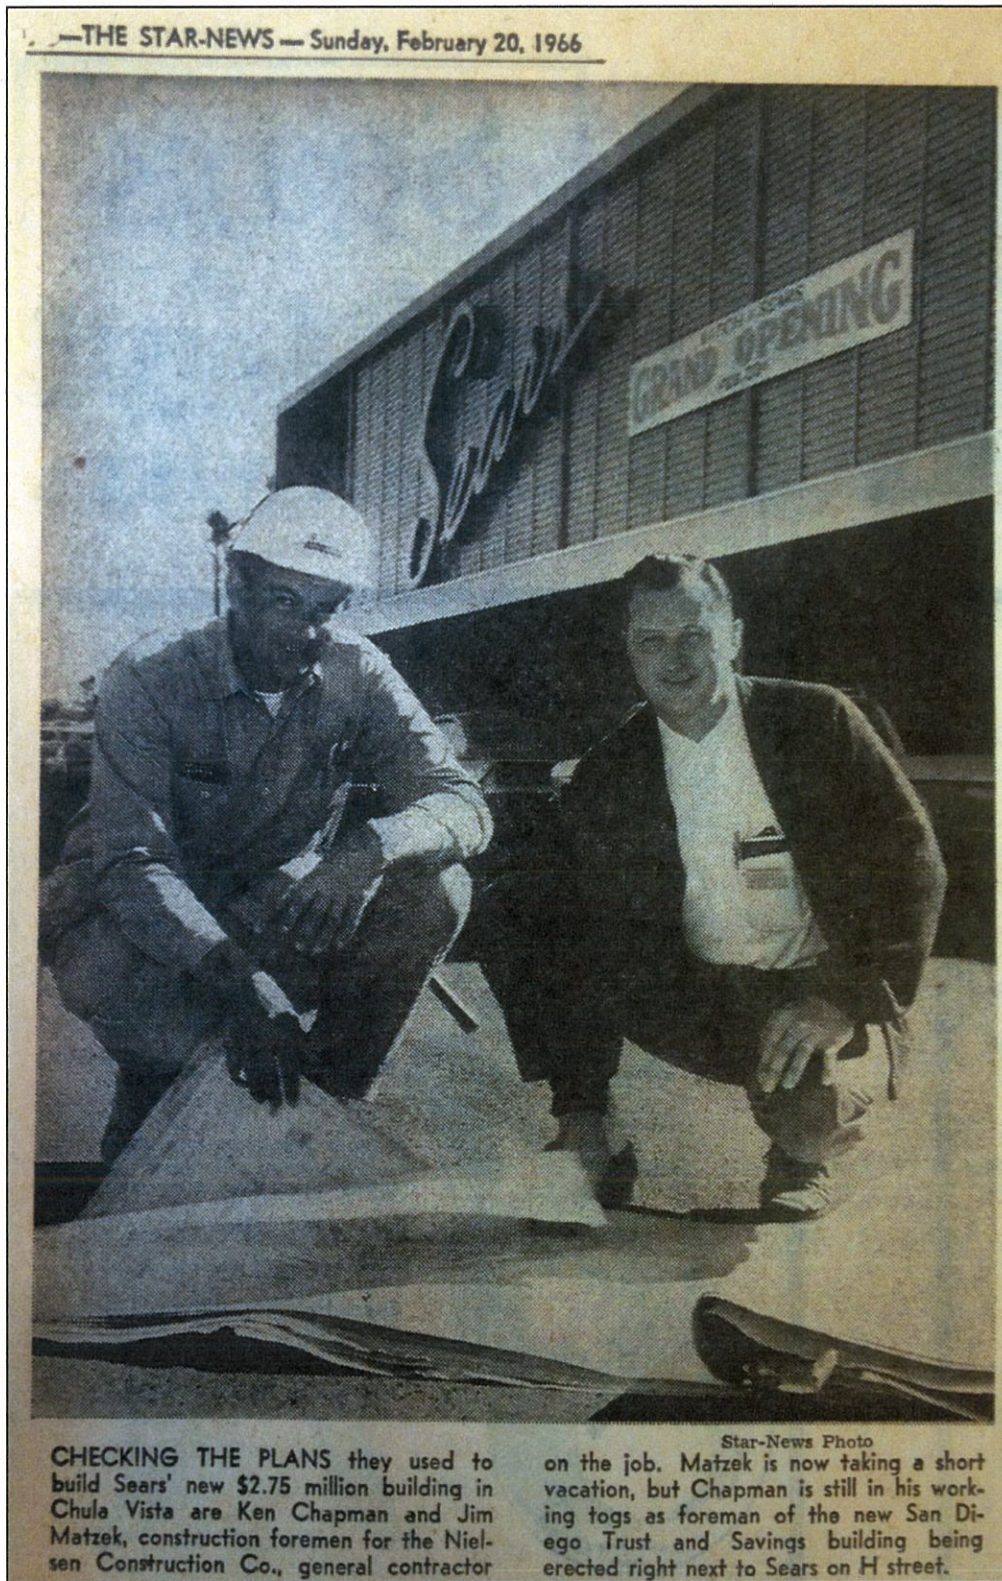
Figure 4-12: Detail of the Chula Vista Sears in the background during the Grand Opening promotions. Source: *The Star-News* February 20, 1966.

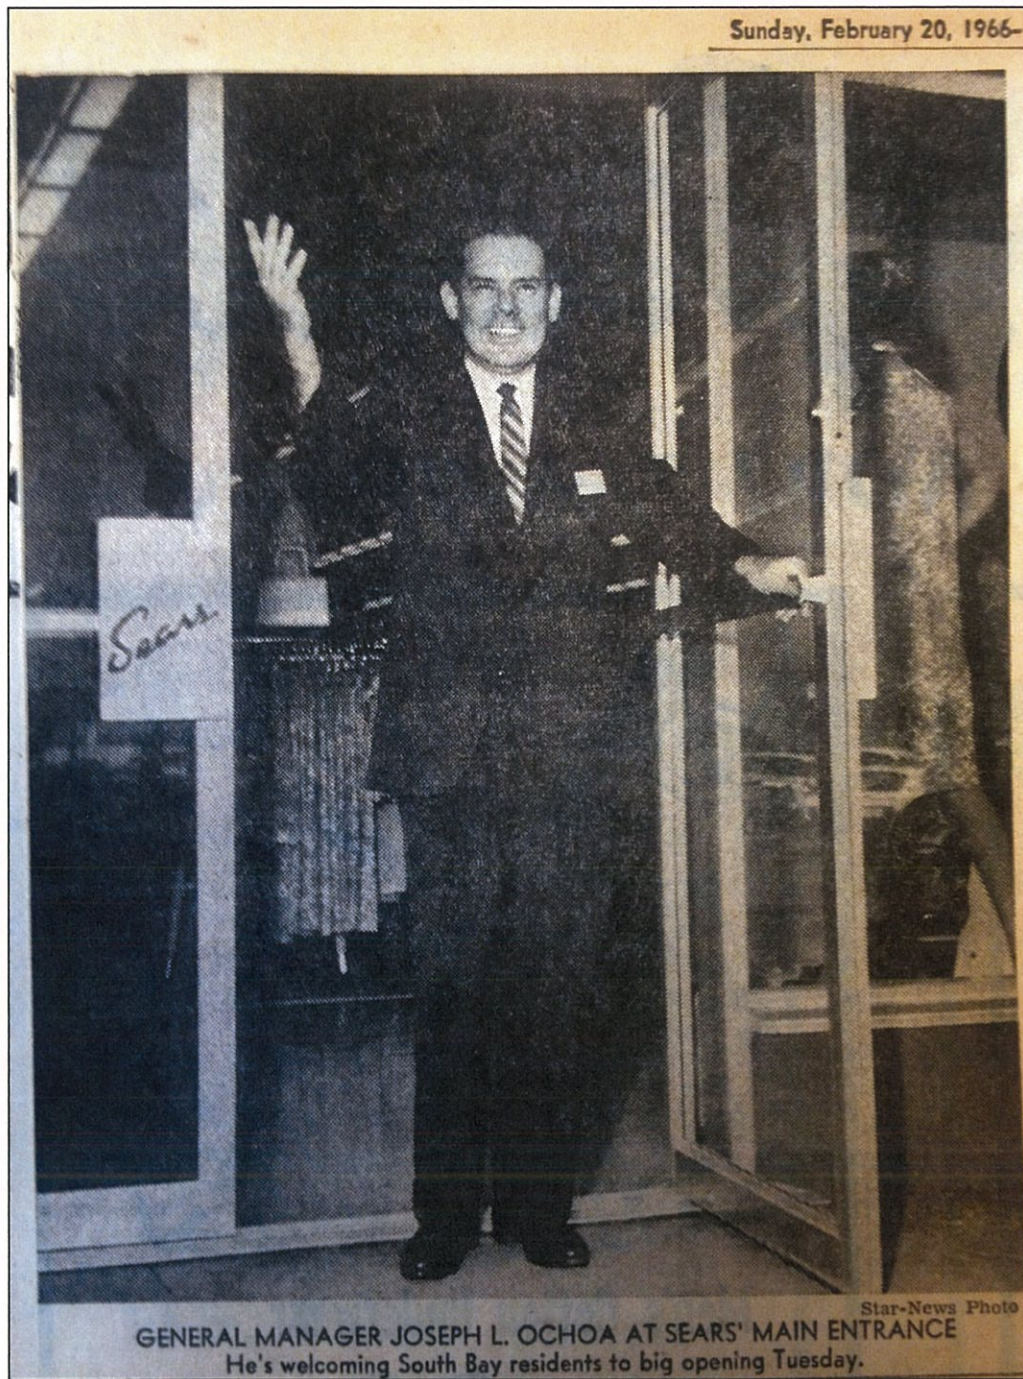
Figure 4-13: Detail of the Chula Vista Sears main entry doors during the Grand Opening promotions. Source: *The Star-News* February 20, 1966.

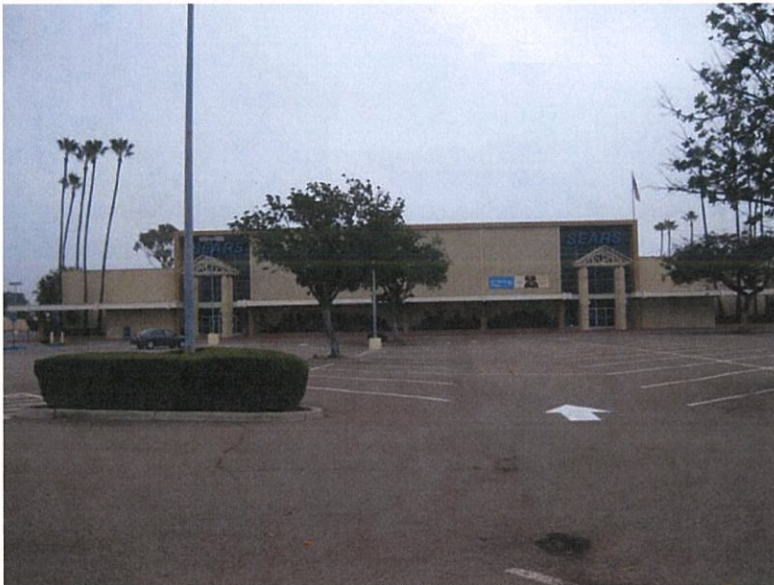
P5a. Photo or Drawing (Photo required for buildings, structures, and objects.)

Looking south at the primary façade. 12/6/12.
12054 - Chula Vista Sears\Images\IMG_5688.JPG

The primary façade faces north toward H Street. Its central bay includes a metal screen wall element at the upper “penthouse” level flanked by large charcoal gray Mirawall panels with aluminum mullions and affixed contemporary “Sears” signage. The original signage was centrally located on the “penthouse” screen wall. Beneath both large panels are glass metal storefronts with multiple entrance doors. The original entrance doors included a scored anodized aluminum push plate detail with “Sears” etched at the center. These doors are no longer extant and have been replaced with contemporary doors. The original display windows adjacent to the entrances have been enclosed and the original stone veneer at the central bay is no longer visible. Tall open-frame gabled canopies were added to the entrances in the 1980s. The original canopy has been notched in these areas to make room for the contemporary entrance structures. Low planters are located at the base of the central bay and along the northeast and northwest corners.
