### This section of the Telegraph Canyon Channel was build in the late 70's.

## The Telegraph Canyon Channel

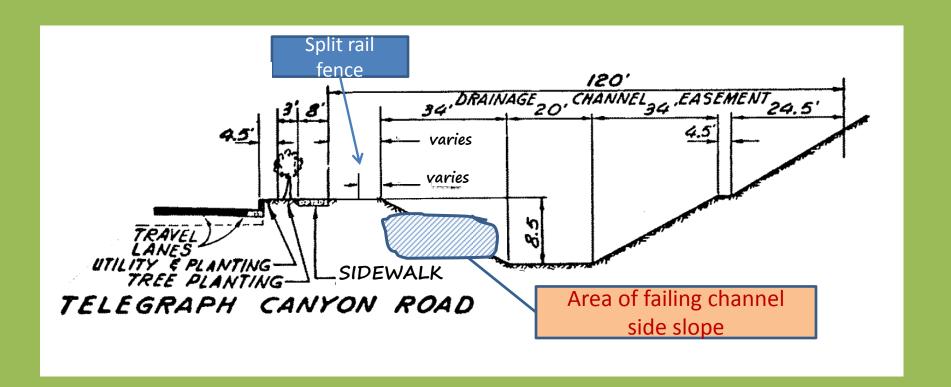
## Original Design

- Designed to convey 3,500 cubic feet of water per second.
- Adjacent to Telegraph Canyon Road (6 Lane Major) averaging about 55,000 daily vehicles.
- Flows year round due to upstream irrigation.
- Original design was a grass lined trapezoidal open channel.

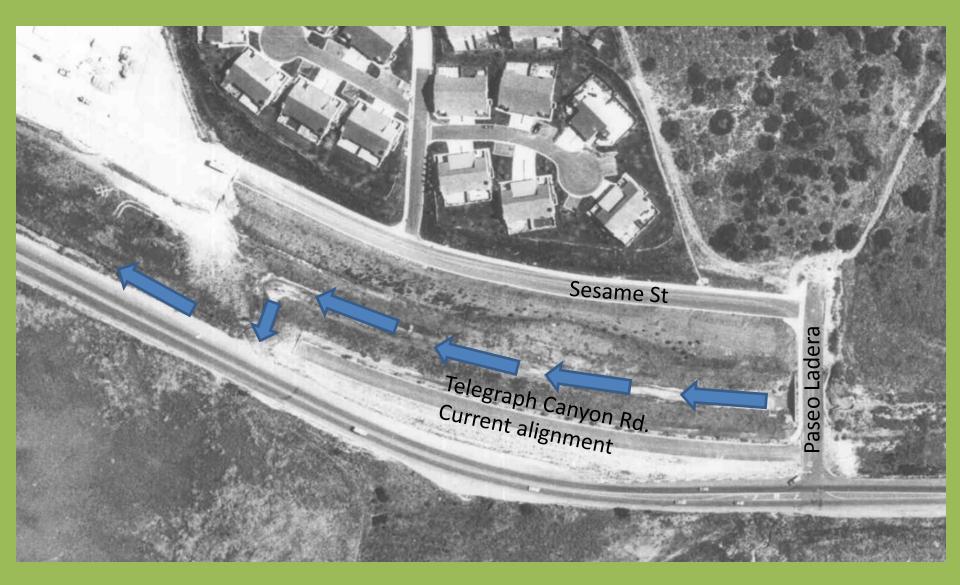
What caused the erosion?

- Curving alignment redirecting flow.
- Original channel alignment is under westbound lanes of Telegraph Canyon Road.
- Year round flows produced dense vegetation.

- Armoring channel Concrete lined or Rip-Rap. Has greater environmental impacts, significantly longer timeline to develop and more costly.
- Buried Secant Pile Wall Sub surface, cast in place, concrete pile retaining wall. No visual impacts, no intrusion into the channel, and short time frame to construct. Recommended by Geotechnical and Civil Engineer (City's consultants) and City Engineer.
