OTAY RIVER RESTORATION PROJECT FINAL HABITAT MITIGATION AND MONITORING PLAN (HMMP)

September 2015, Revised March 2016, Final April 2016

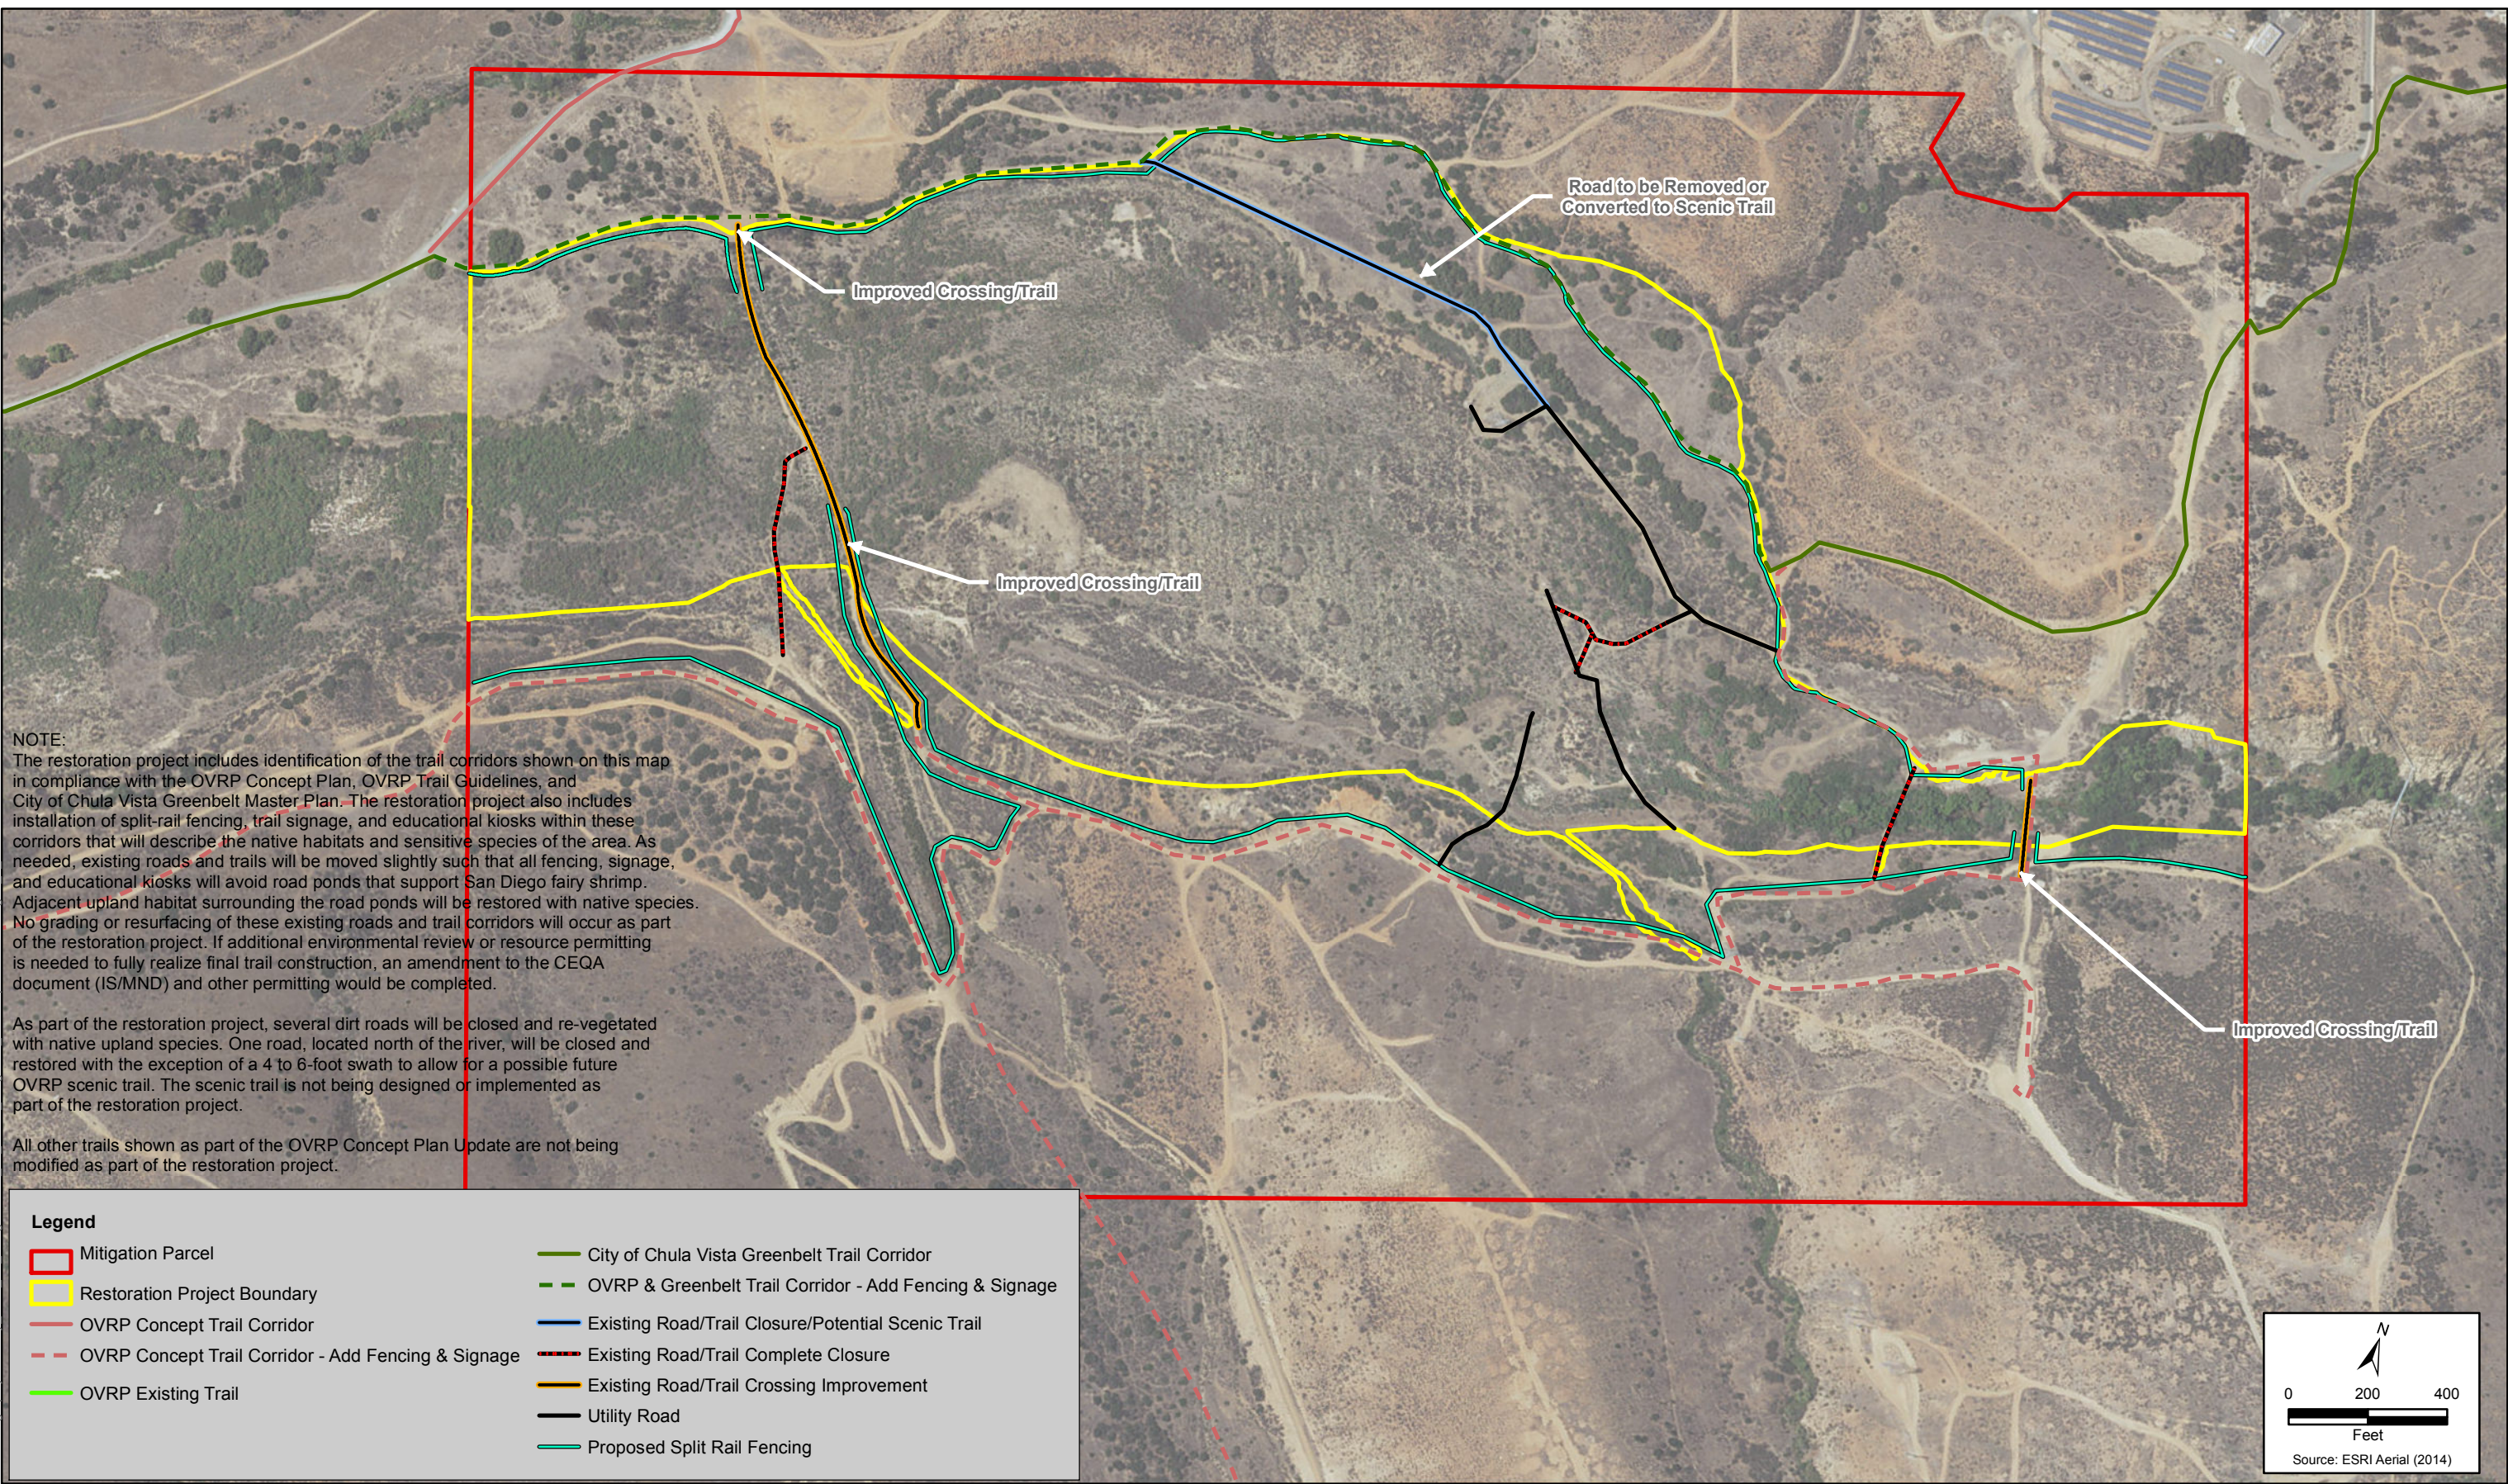
Figure 3-6
Mitigation Parcel Trails
Otay River Restoration Project

Proposed general improvements to each crossing would include over-excavation, underlain by native large rock, and reformed to match the stream profile as much as possible for safe crossing and utility protection. The armoring would be provided to prevent the washing away of the crossings during flood events and eliminate the current berming resulting from consistent vehicle use during wet conditions. These artificial berms currently impound water upstream and force the limited surface hydrology subsurface. In addition, the restoration project proposes four road closures that would be revegetated per the HMMP as these are either redundant or relocated as discussed with U.S. Border Patrol, SDG&E, and OWD. ICF and the City of Chula Vista have been in communication with these entities on these road closures, and all are in agreement that they would not limit their ability to achieve their missions. Border Patrol has asked to install reflectors along trail fencing at road intersections, trail closures, and at the river crossings at specific locations. The exact location of these reflectors will be coordinated with the Border Patrol to ensure safe passage.
