# Telegraph Canyon Channel Nexus Study (DR203)

November 24, 2015

DR 203

**ATKINS**  
3570 Carmel Mountain Road, Suite 300  
San Diego, California 92130  
Atkins Project No.: 100046838

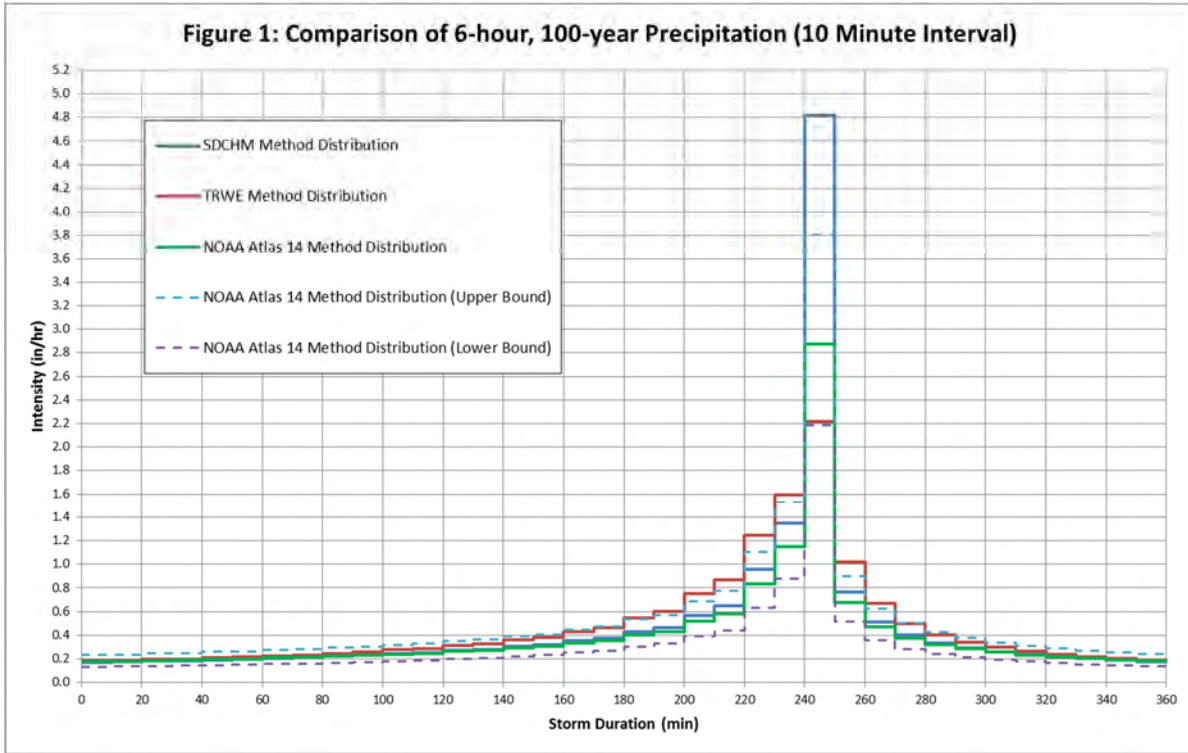
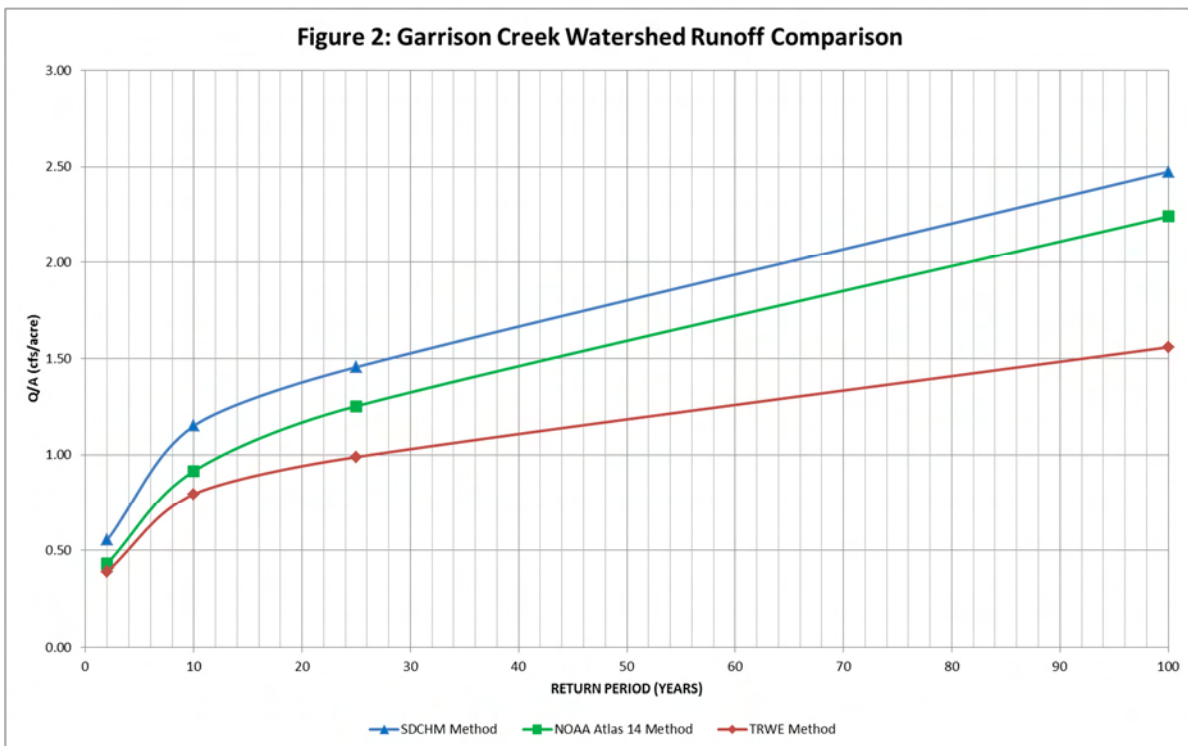
Figure 1 illustrates the distribution of a 6-hour, 100-year storm event in 10-minute intervals using the SDCHM Method, the TRWE Method, and the NOAA Atlas 14 Method at the Telegraph Canyon watershed centroid. It is clear that the SDCHM produces the highest intensity, followed by NOAA Atlas 14, and then by the TRWE Method. The SDCHM Method calculates a maximum intensity of 4.82 in/hour. This is due to the extremely conservative nature of the mathematical power-law equation recommended in the SDCHM ( $I = k/t^n$ ). As the time of duration approaches zero, the intensity becomes infinitely large, as exhibited in Figure 1. The NOAA Method produced the second highest rainfall intensity, reaching an intensity of 2.87 in/hour. This intensity is based upon the NOAA Atlas 14, Volume 6, Version 2 PDS-based point precipitation frequency estimates with 90% confidence intervals. When the upper and lower confidence limits were considered, intensities of 3.81 and 2.19 inches/hour were estimated, respectively. The lower confidence limit produces a liberal intensity value that is less than any intensity rendered by a published depth-area reduction factor for a small (>50 mi<sup>2</sup>) watershed, whereas the upper confidence limit produces an overly-conservative value (that still remains less than the SDCHM Method intensity). The TRWE Method produced the lowest rainfall intensity at 2.21 in/hour. The TRWE Method improves upon the SDCHM Method because the mathematical power-law equation is improved to produce a finite maximum value, even for a time of duration equal to 0 minutes.

A case study performed on the Garrison Creek Watershed in Oceanside demonstrated that the NOAA values were closer to TRWE values than to SDHM values for return periods smaller than 25 years and closer to SDHM values than to TRWE values for return period equal or larger than 25 years (Figure 2). This result was expected, as the annual maxima series behind the NOAA analysis has a tendency to overestimate the standard deviation of the data for large return periods, and therefore generate a larger intensity than the more site-specific storm maxima performed by TRWE. In any case, it is clear that the SDCHM results are extremely conservative.
